# Impact Evaluation of the 2012 Rooftop Unit Tune-up Initiative

October 21, 2014

Prepared by:  
John Walczyk

Cadmus

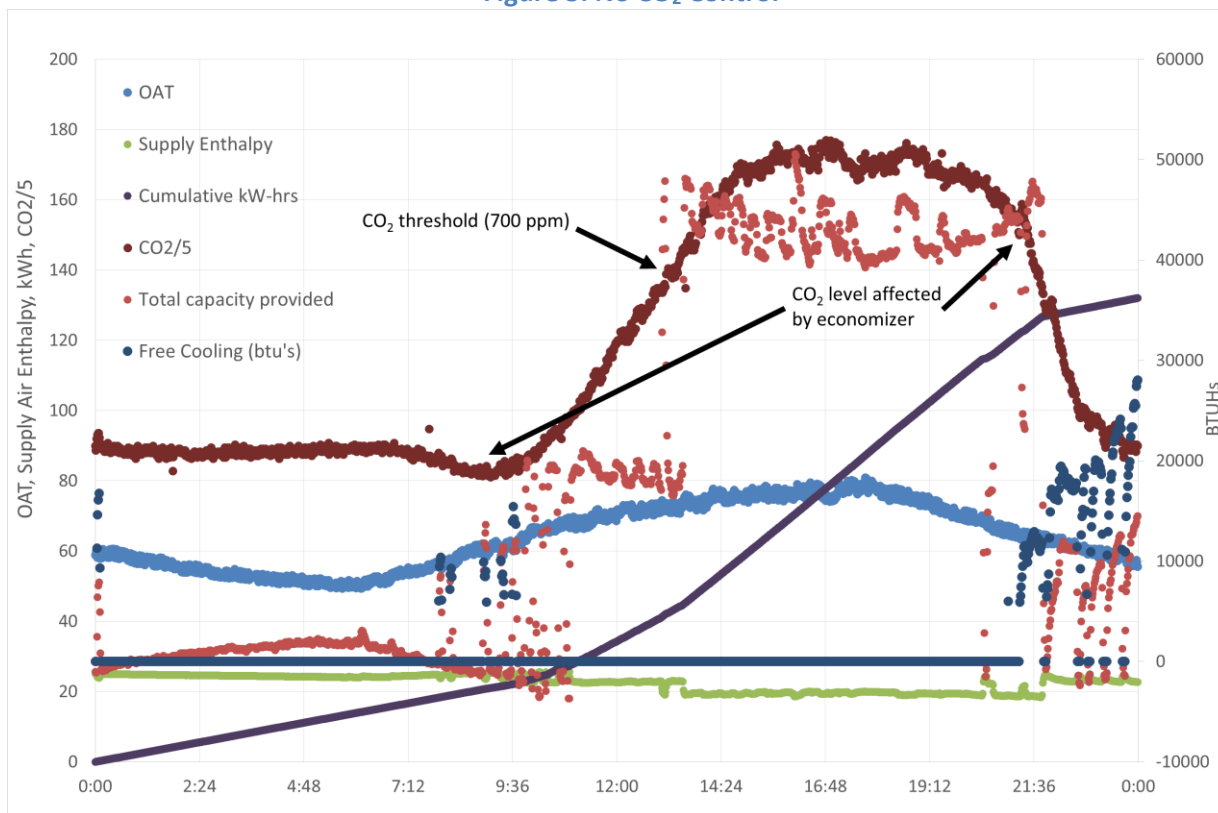
Figure 5. No CO<sub>2</sub> Control

mechanically functional economizer but a 62-degree (Fahrenheit) changeover temperature (some free cooling around 8 am and again after 9 pm). The data indicate that this RTU had no CO<sub>2</sub> control. When the economizer opens, bringing in outside air during the economizing period, the CO<sub>2</sub> levels are consequently affected (pointed out in the graph). But as CO<sub>2</sub> rises throughout the day, we are able to confirm the economizer does not respond through review of the free-cooling estimate (dark blue line), which is 0 even as temperatures remain below 68 degrees<sup>9</sup>. We also see that CO<sub>2</sub> levels rise well beyond the acceptable threshold.

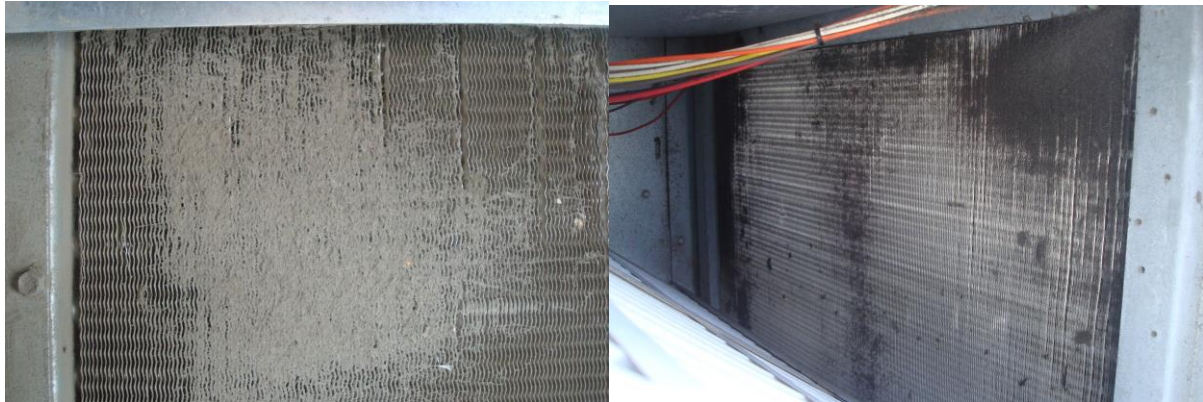
**Figure 6. Example of Dirty Evaporator Coil and Airflow Restriction**

Figure 6 shows two examples of dirty evaporator coils. Both are evidence that filters had not been changed and neither of these systems had been cleaned for some time, possibly since implementation of the tune-up measures.

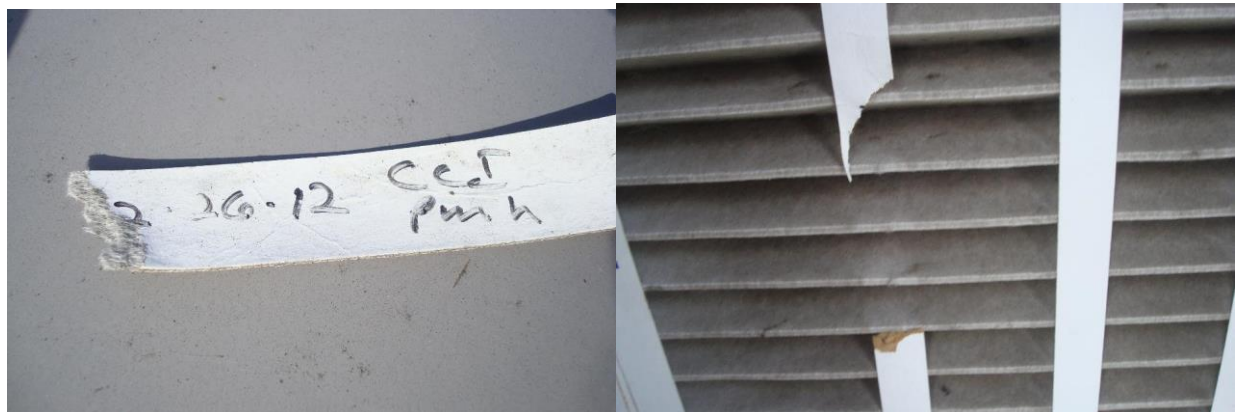
**Figure 7. Dirty Air Filter**

Figure 7 shows an example of an air filter dated February 2012 indicated it had not been changed since the day the tune-up was performed.

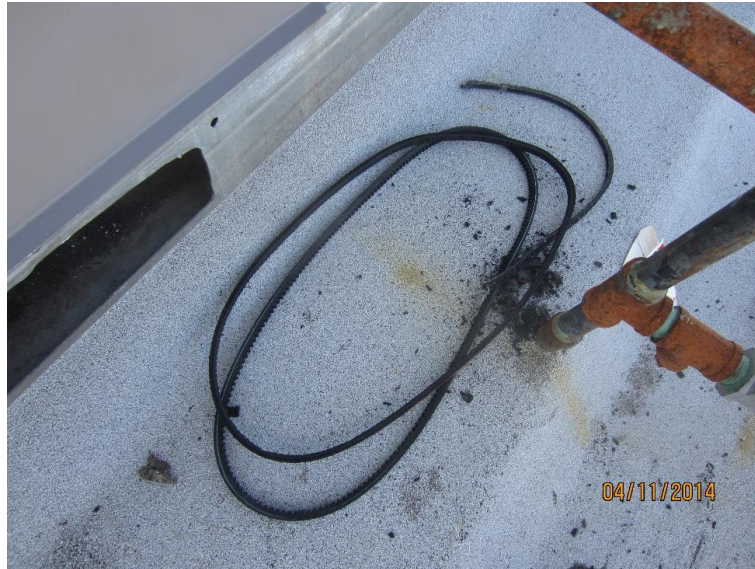
Figure 8. Poor Maintenance Practices

We noticed several sites with poor general maintenance. One site had an RTU with several broken belts near the unit (Figure 8). The belt recently installed on the fan was very loose and was slipping. It was already worn and ready to break. A simple adjustment to the tensioner was necessary and would

alleviate this problem. This type of problem causes airflow issues, not just maintenance problems. Further investigation of the other five RTUs at this site revealed two units with broken belts and evidence of little or no maintenance.

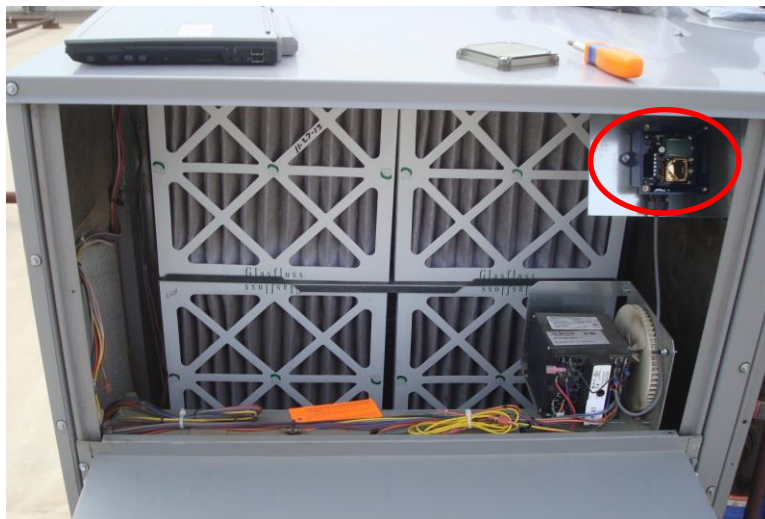
**Figure 9. Incorrect CO<sub>2</sub> Sensor Placement**

Cadmus observed incorrect sensor placement in three of 41 RTUs.

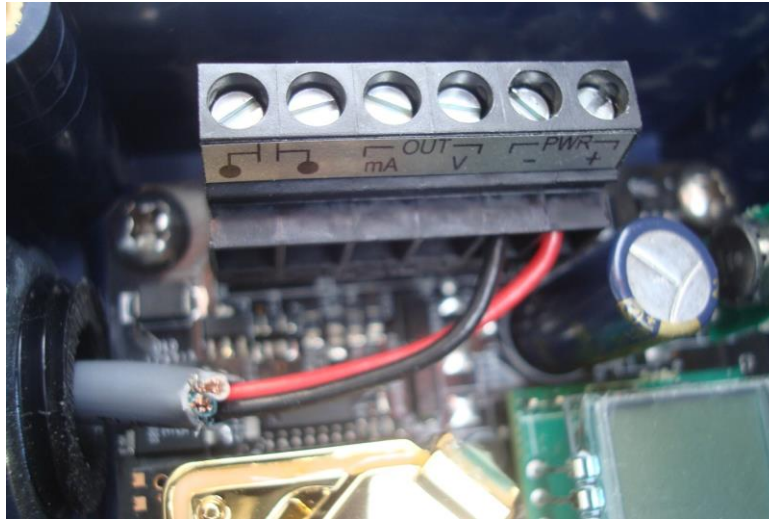
Figure 10. Incorrect CO<sub>2</sub> Setup

Figure 10 shows the terminal block for the typical CO<sub>2</sub> sensor installed through the program. In this example, the sensor is merely powered—it does not actually send a signal to control the economizer. Cadmus found eight CO<sub>2</sub> sensors that were not correctly wired and two more that were not functional (failed). The meter data analysis found additional instances of failed demand control ventilation (DCV) because the economizer was not responsive. In total, 17 of 41 RTUs did not have properly functioning DCV.
