**WESTMORELAND  
UNION MANOR**

**SENIOR HOUSING ENERGY  
RENOVATION**

## Westmoreland Union Manor – Building Design

# Mechanical Systems and Energy Modeling

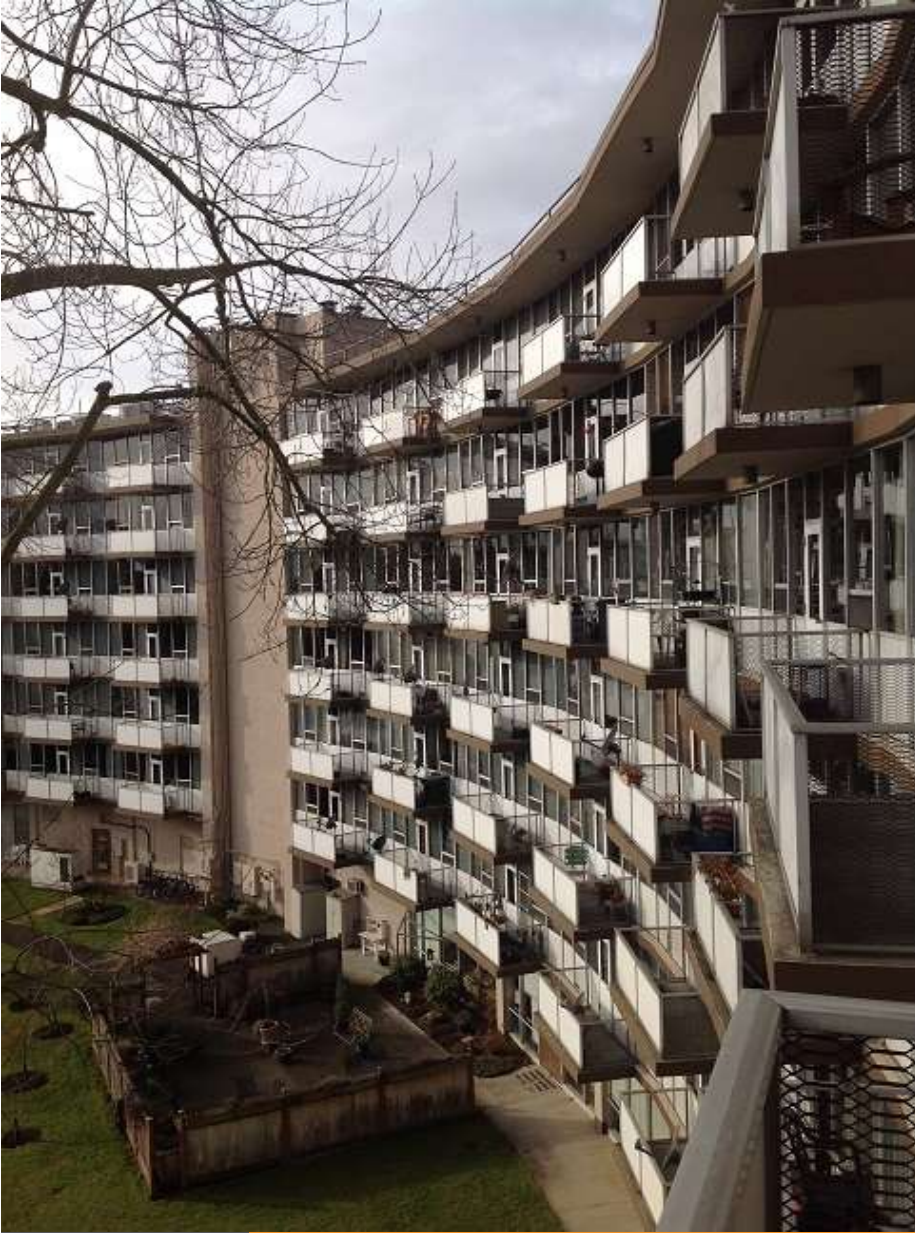
- Slab on grade foundation system
- Concrete lift slab construction – 9" PT deck from second floor to roof.
- Steel columns support for PT deck
- Concrete exterior walls at ends of building with concrete elevator/stair core

Primary Structure

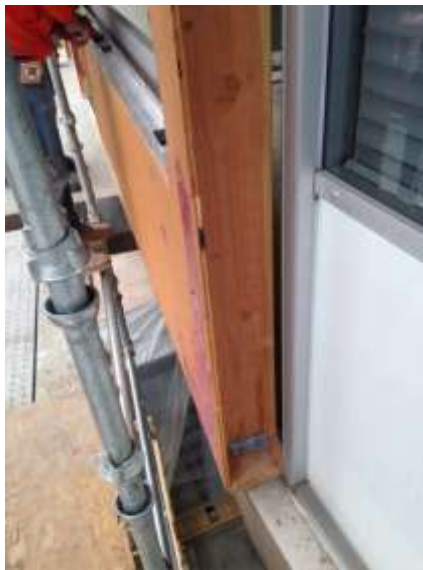
1 TYP. EXTERIOR WALL - TYPE A  
SCALE: 3" = 1'-0"

Edge of PT Deck

New wall system increased length of apartment by 1-3/4", Remember every bit counts

## Innovation – Exterior Envelope, Wall

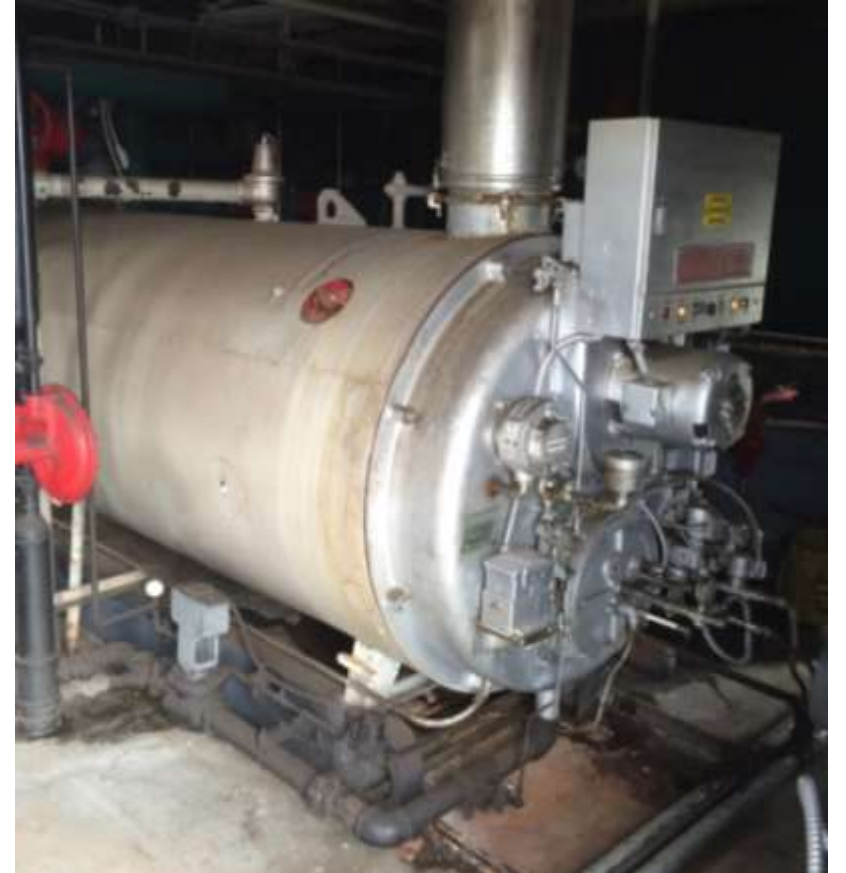
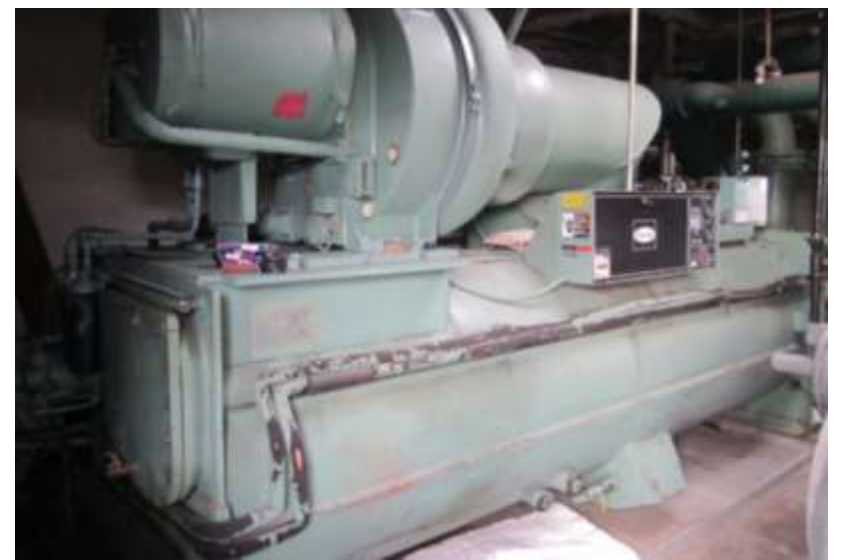
- Rooftop Penthouse Mechanical Room
- Dual Cleaver Brooks, 4200 MBH Firetube boilers (original), 180 F
- Carrier Centrifugal Chiller, 300 tons, R-11
- Baltimore Aircoil Cooling Tower, 300 tons
- Two Pipe Change over system
- Pneumatic controls

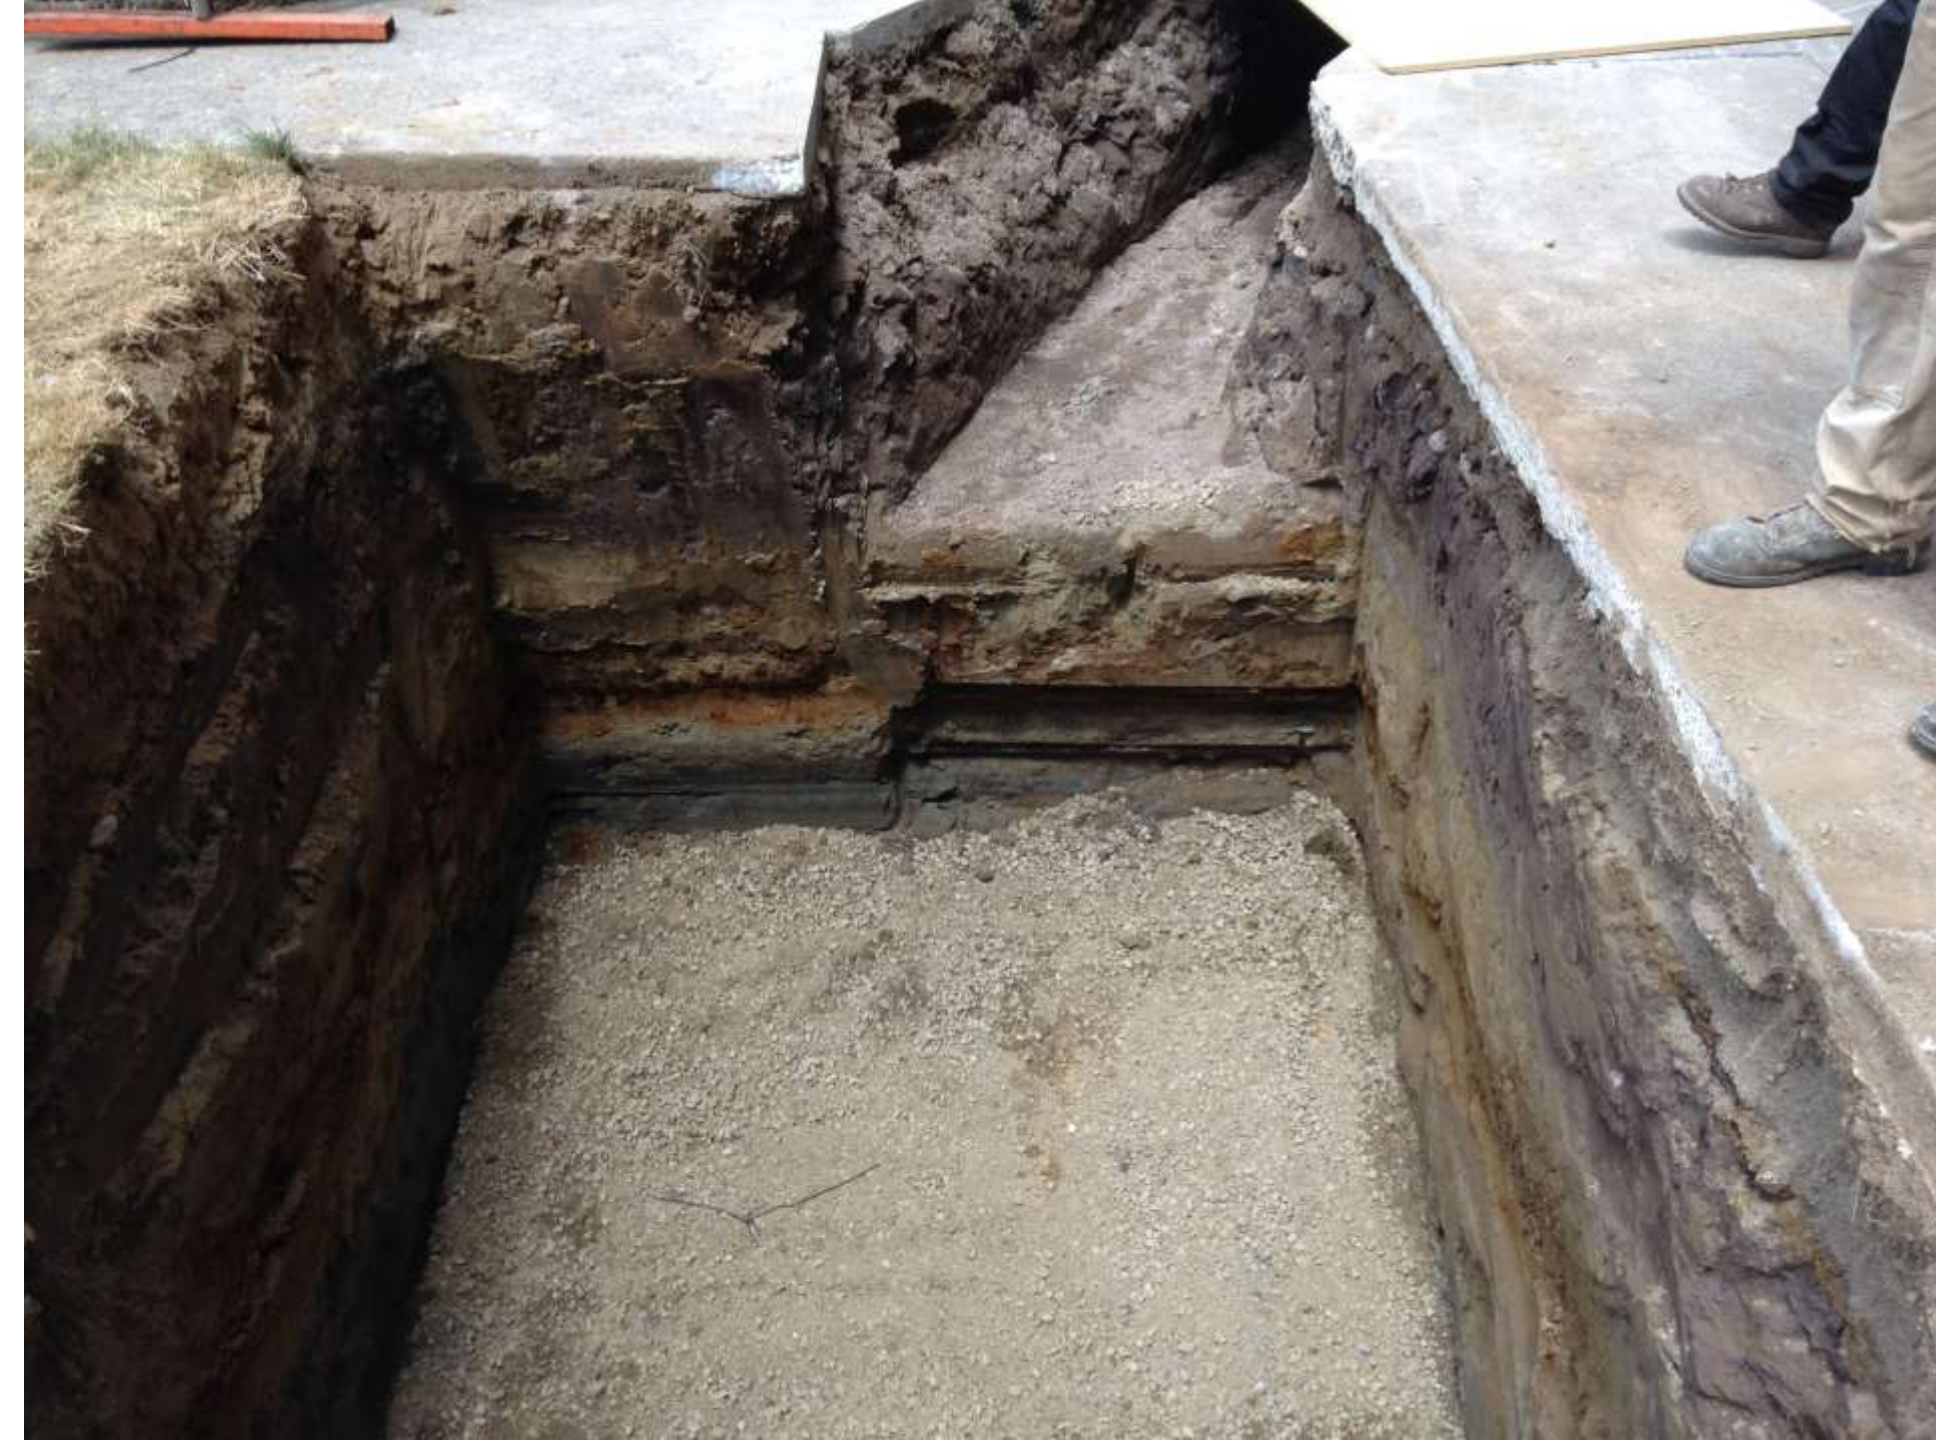
New Domestic  
Water Routing per  
PWB  
Requirements

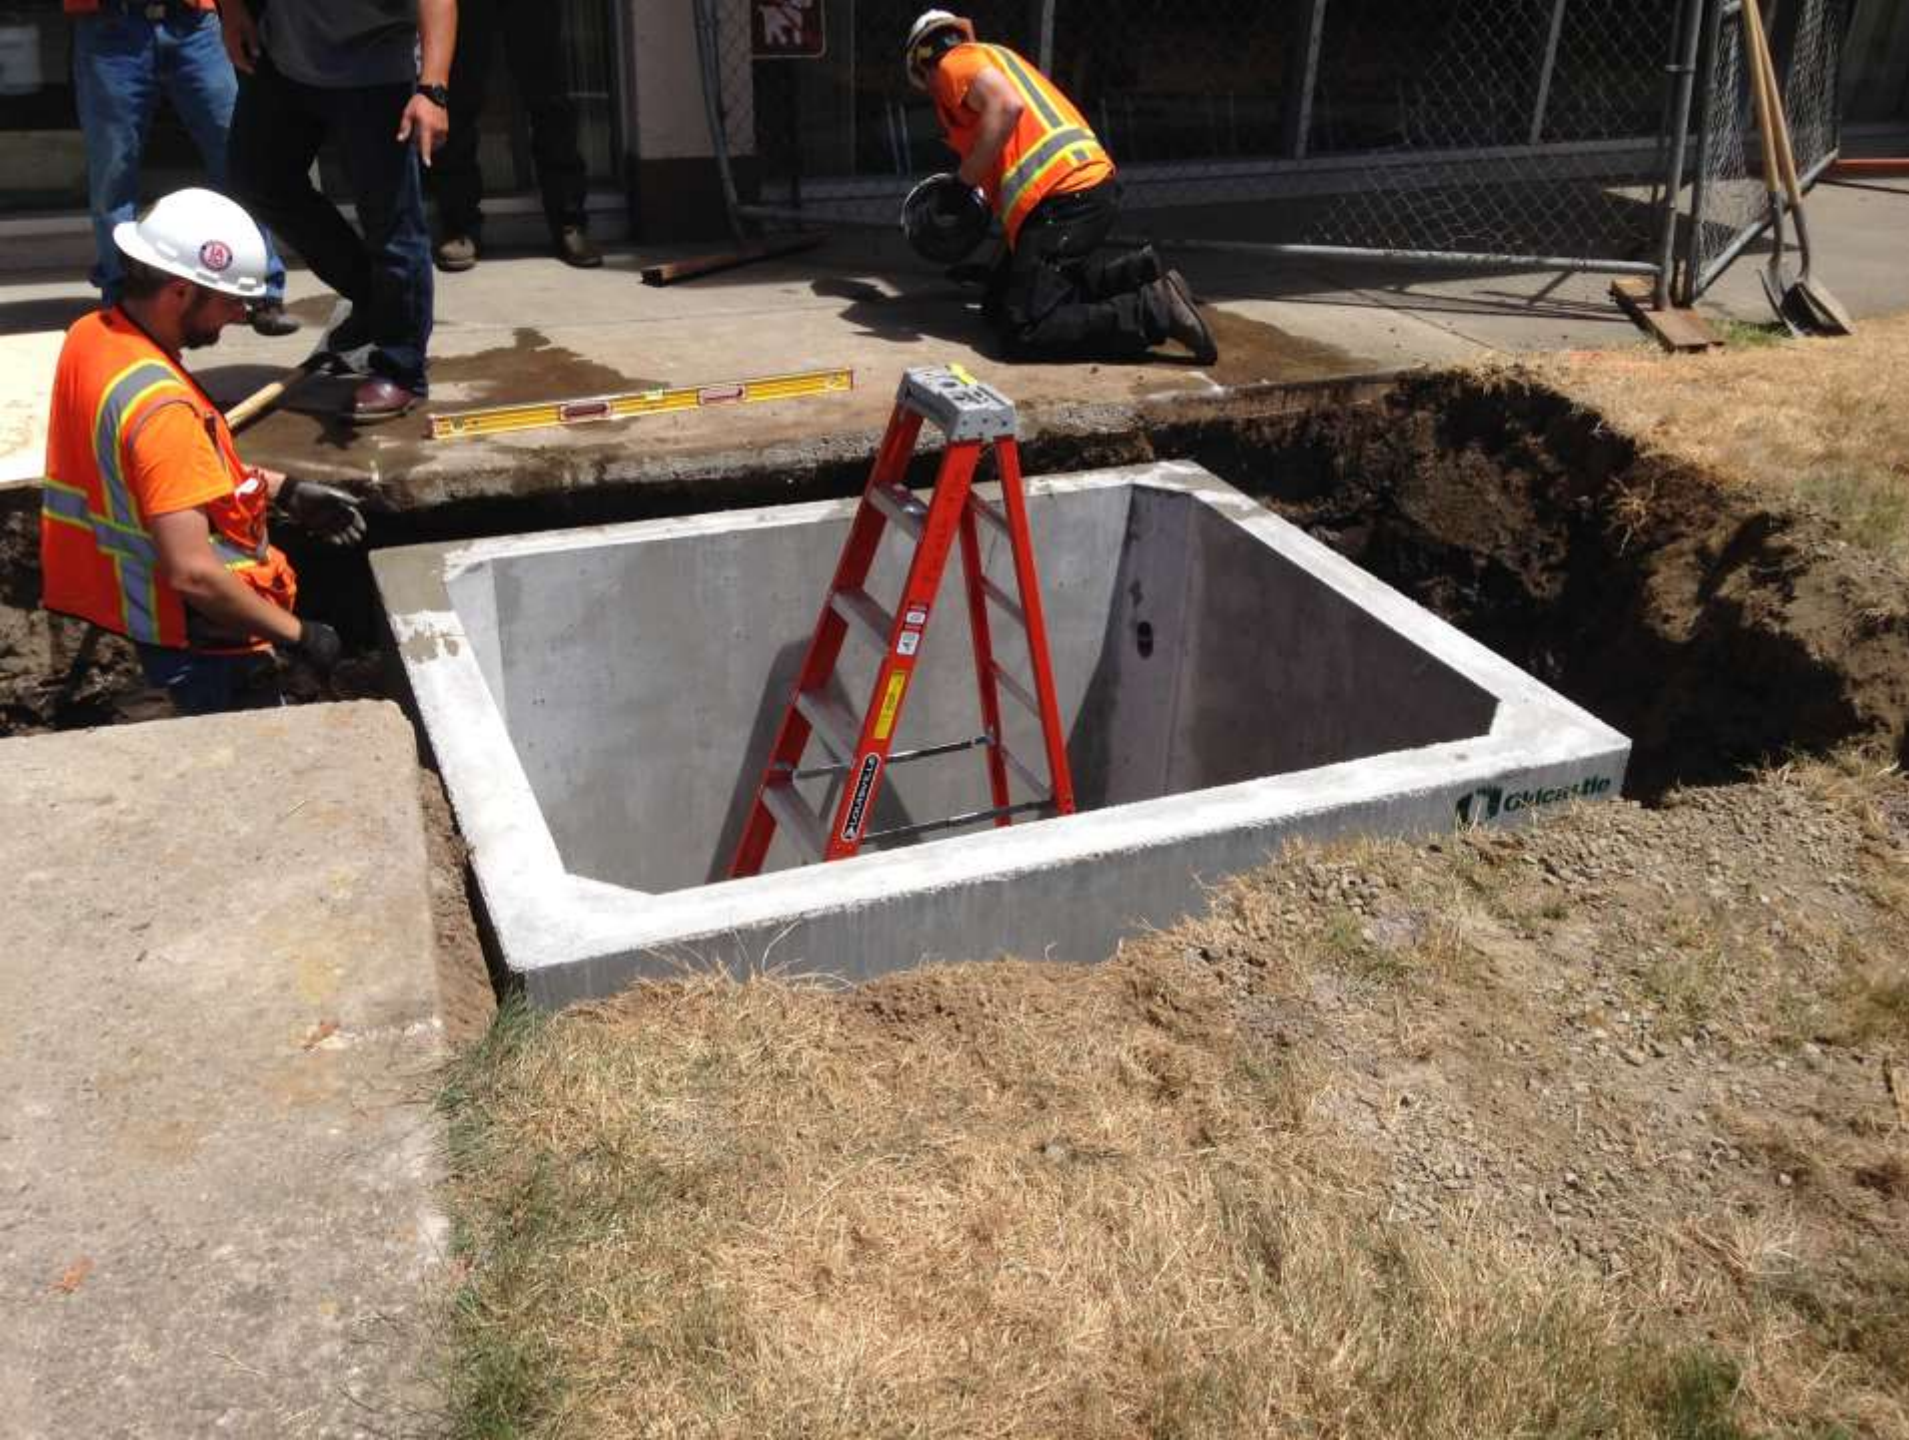
New Dom  
Water DCVA  
(Double-  
Check) Vault  
Prep

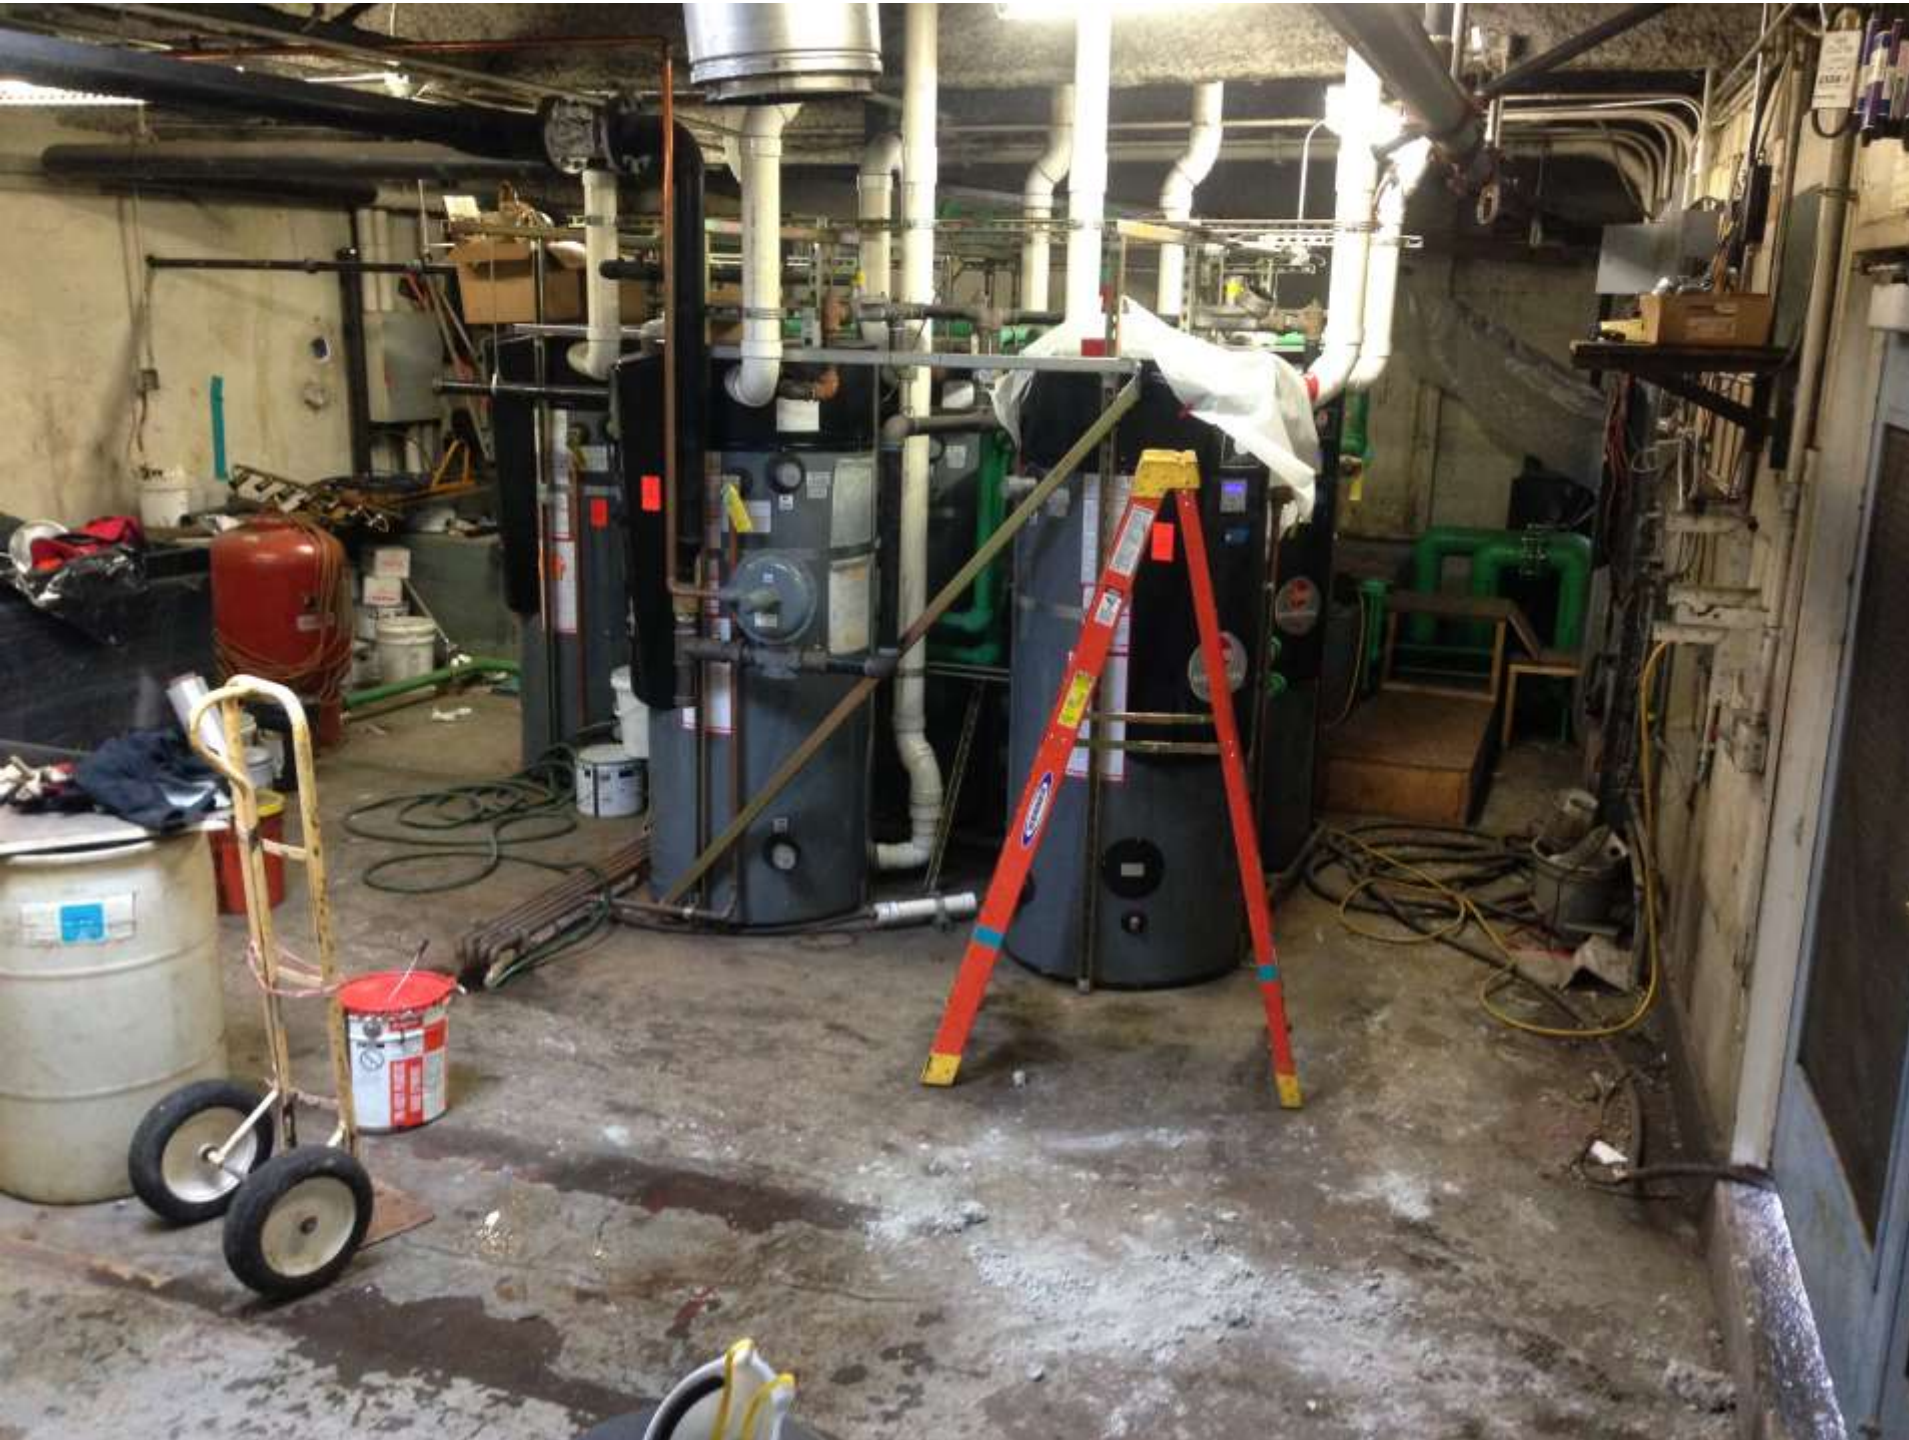
Rigging and  
positioning

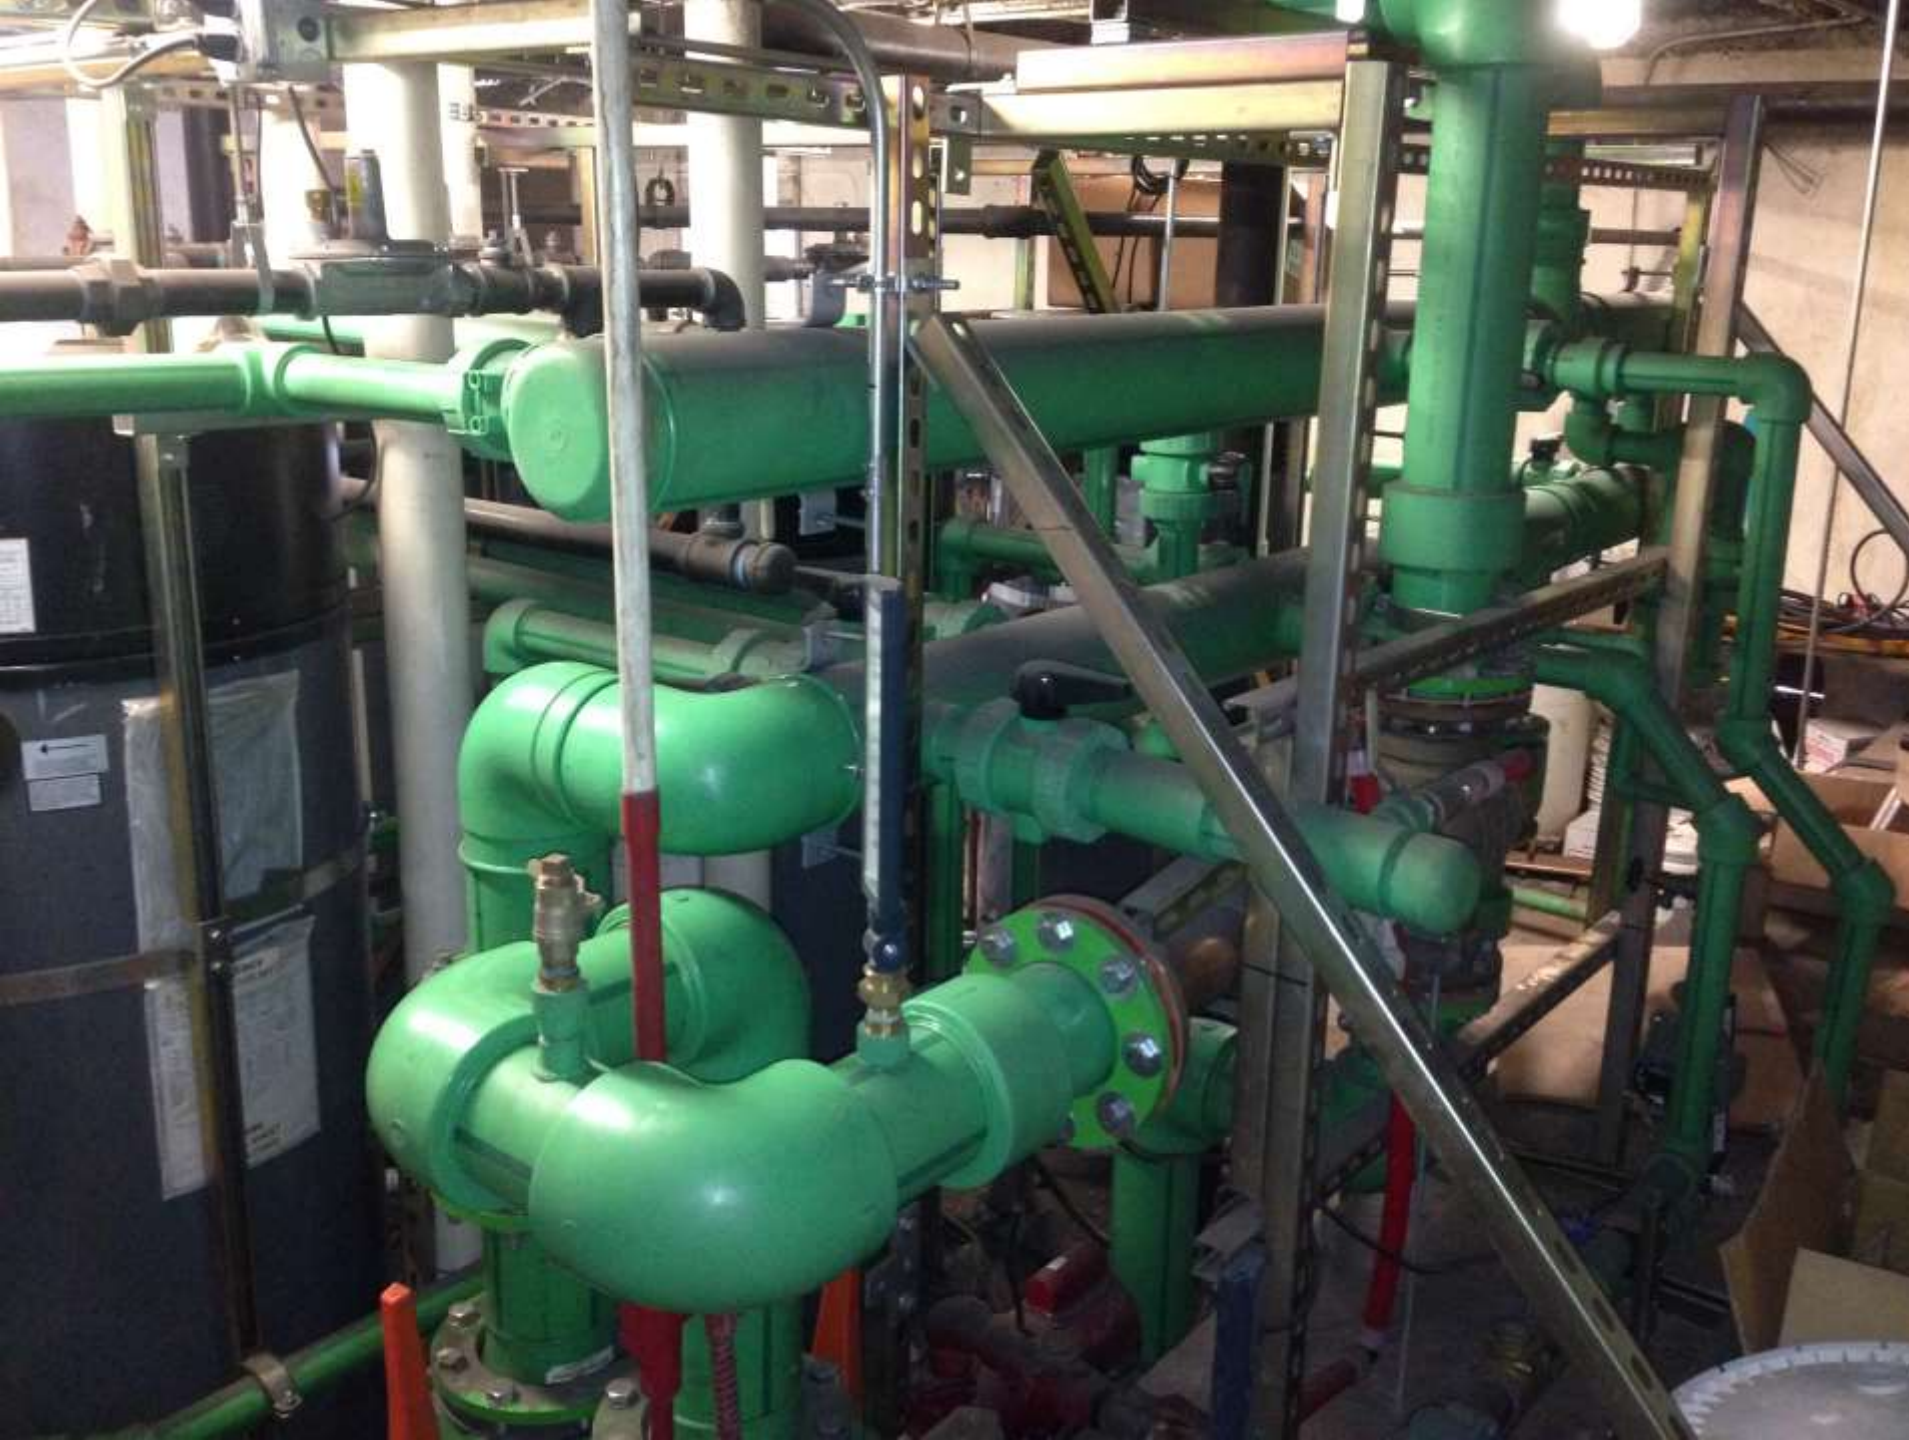
Boiler  
combustion/  
exhaust ducting  
in place

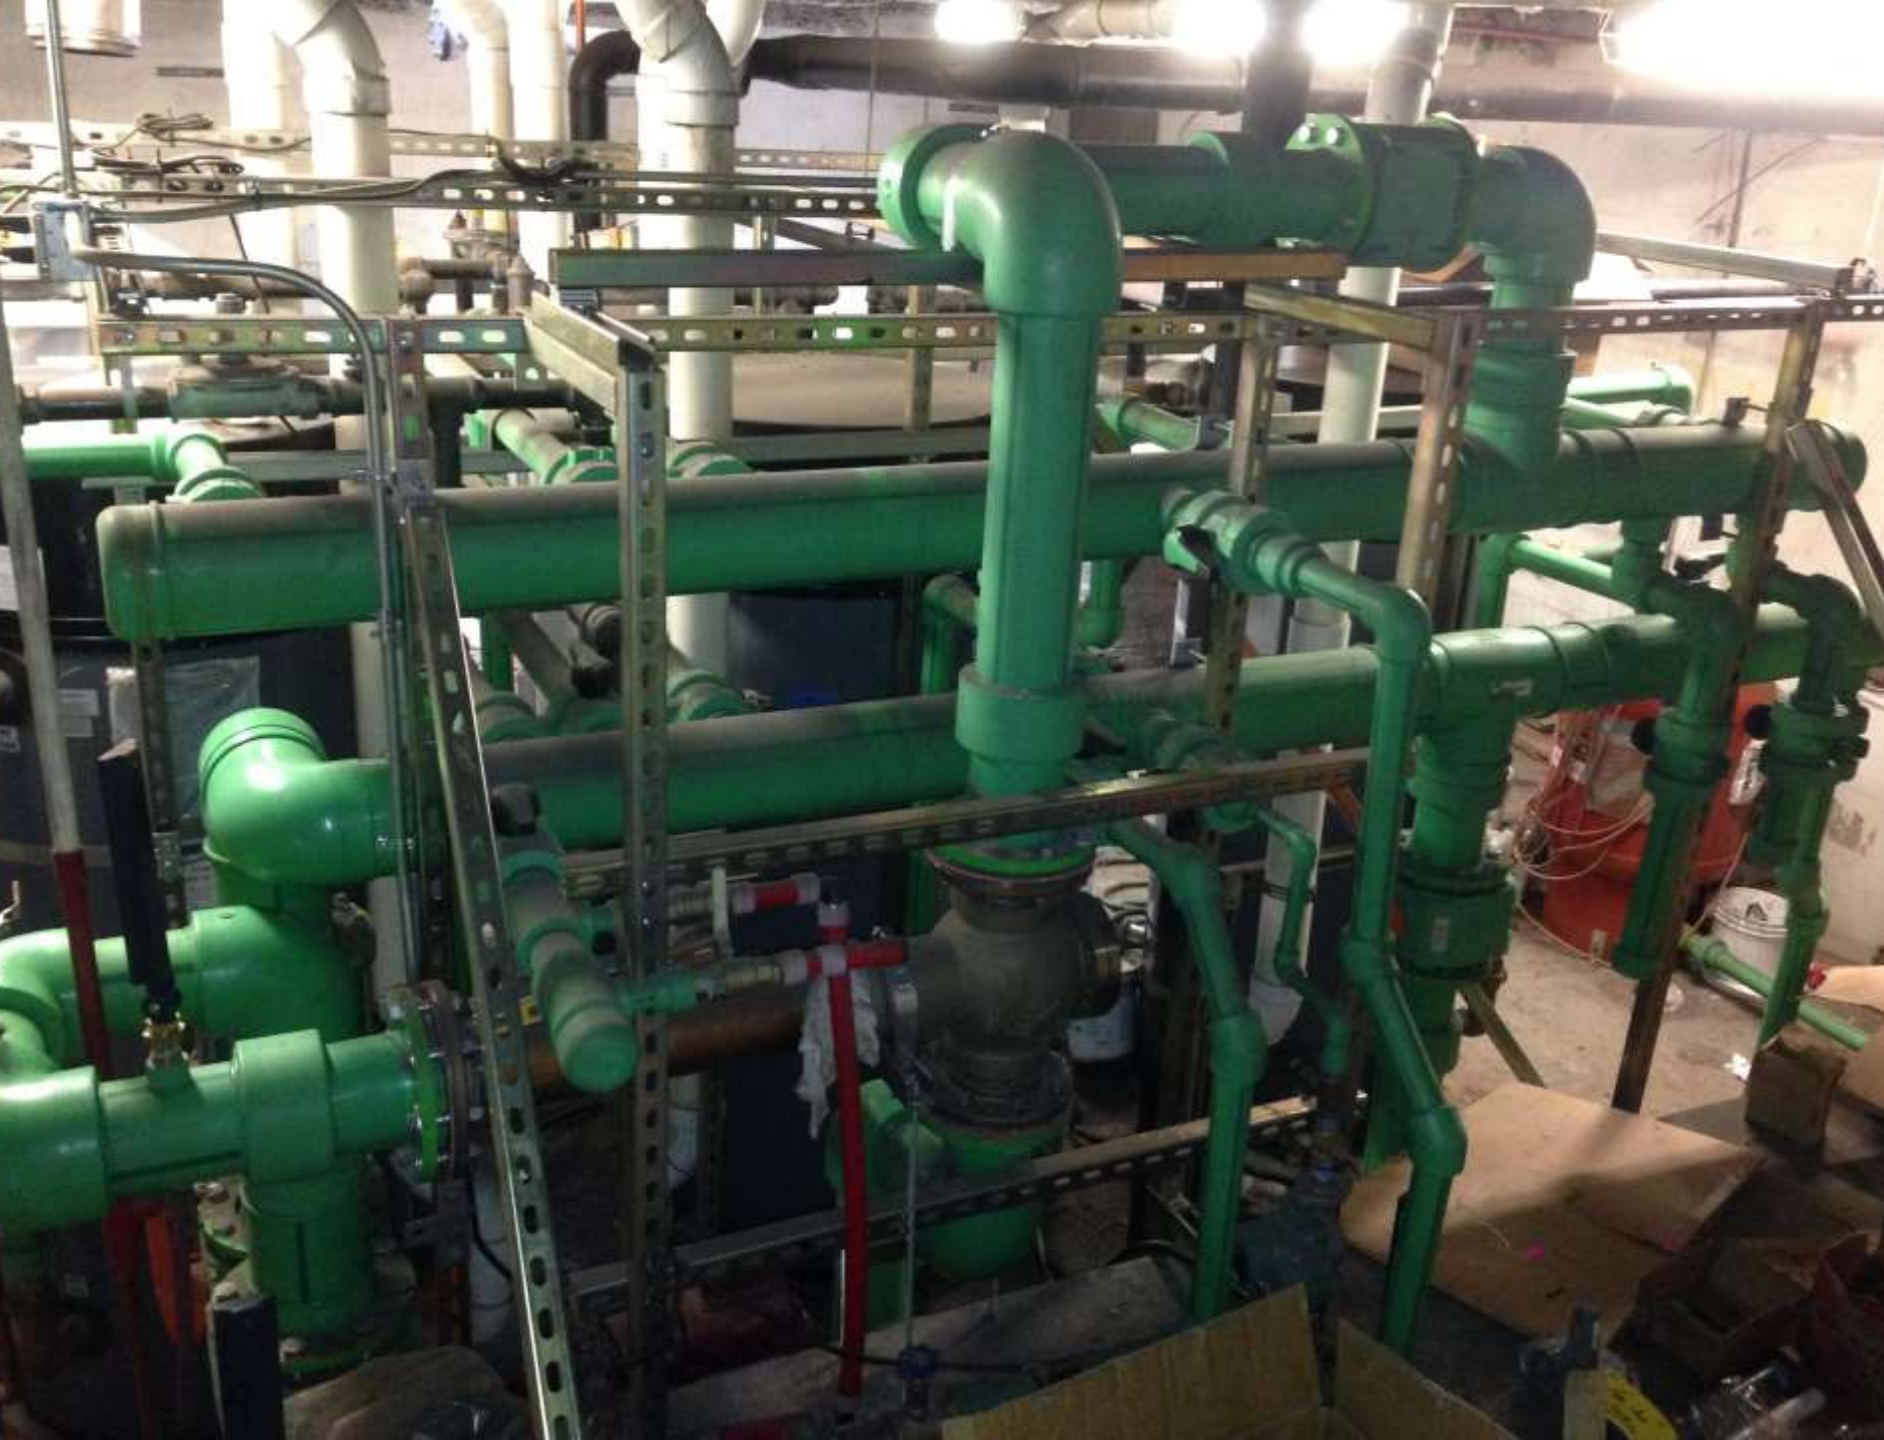
Main Dom Boiler  
Header  
Assembly

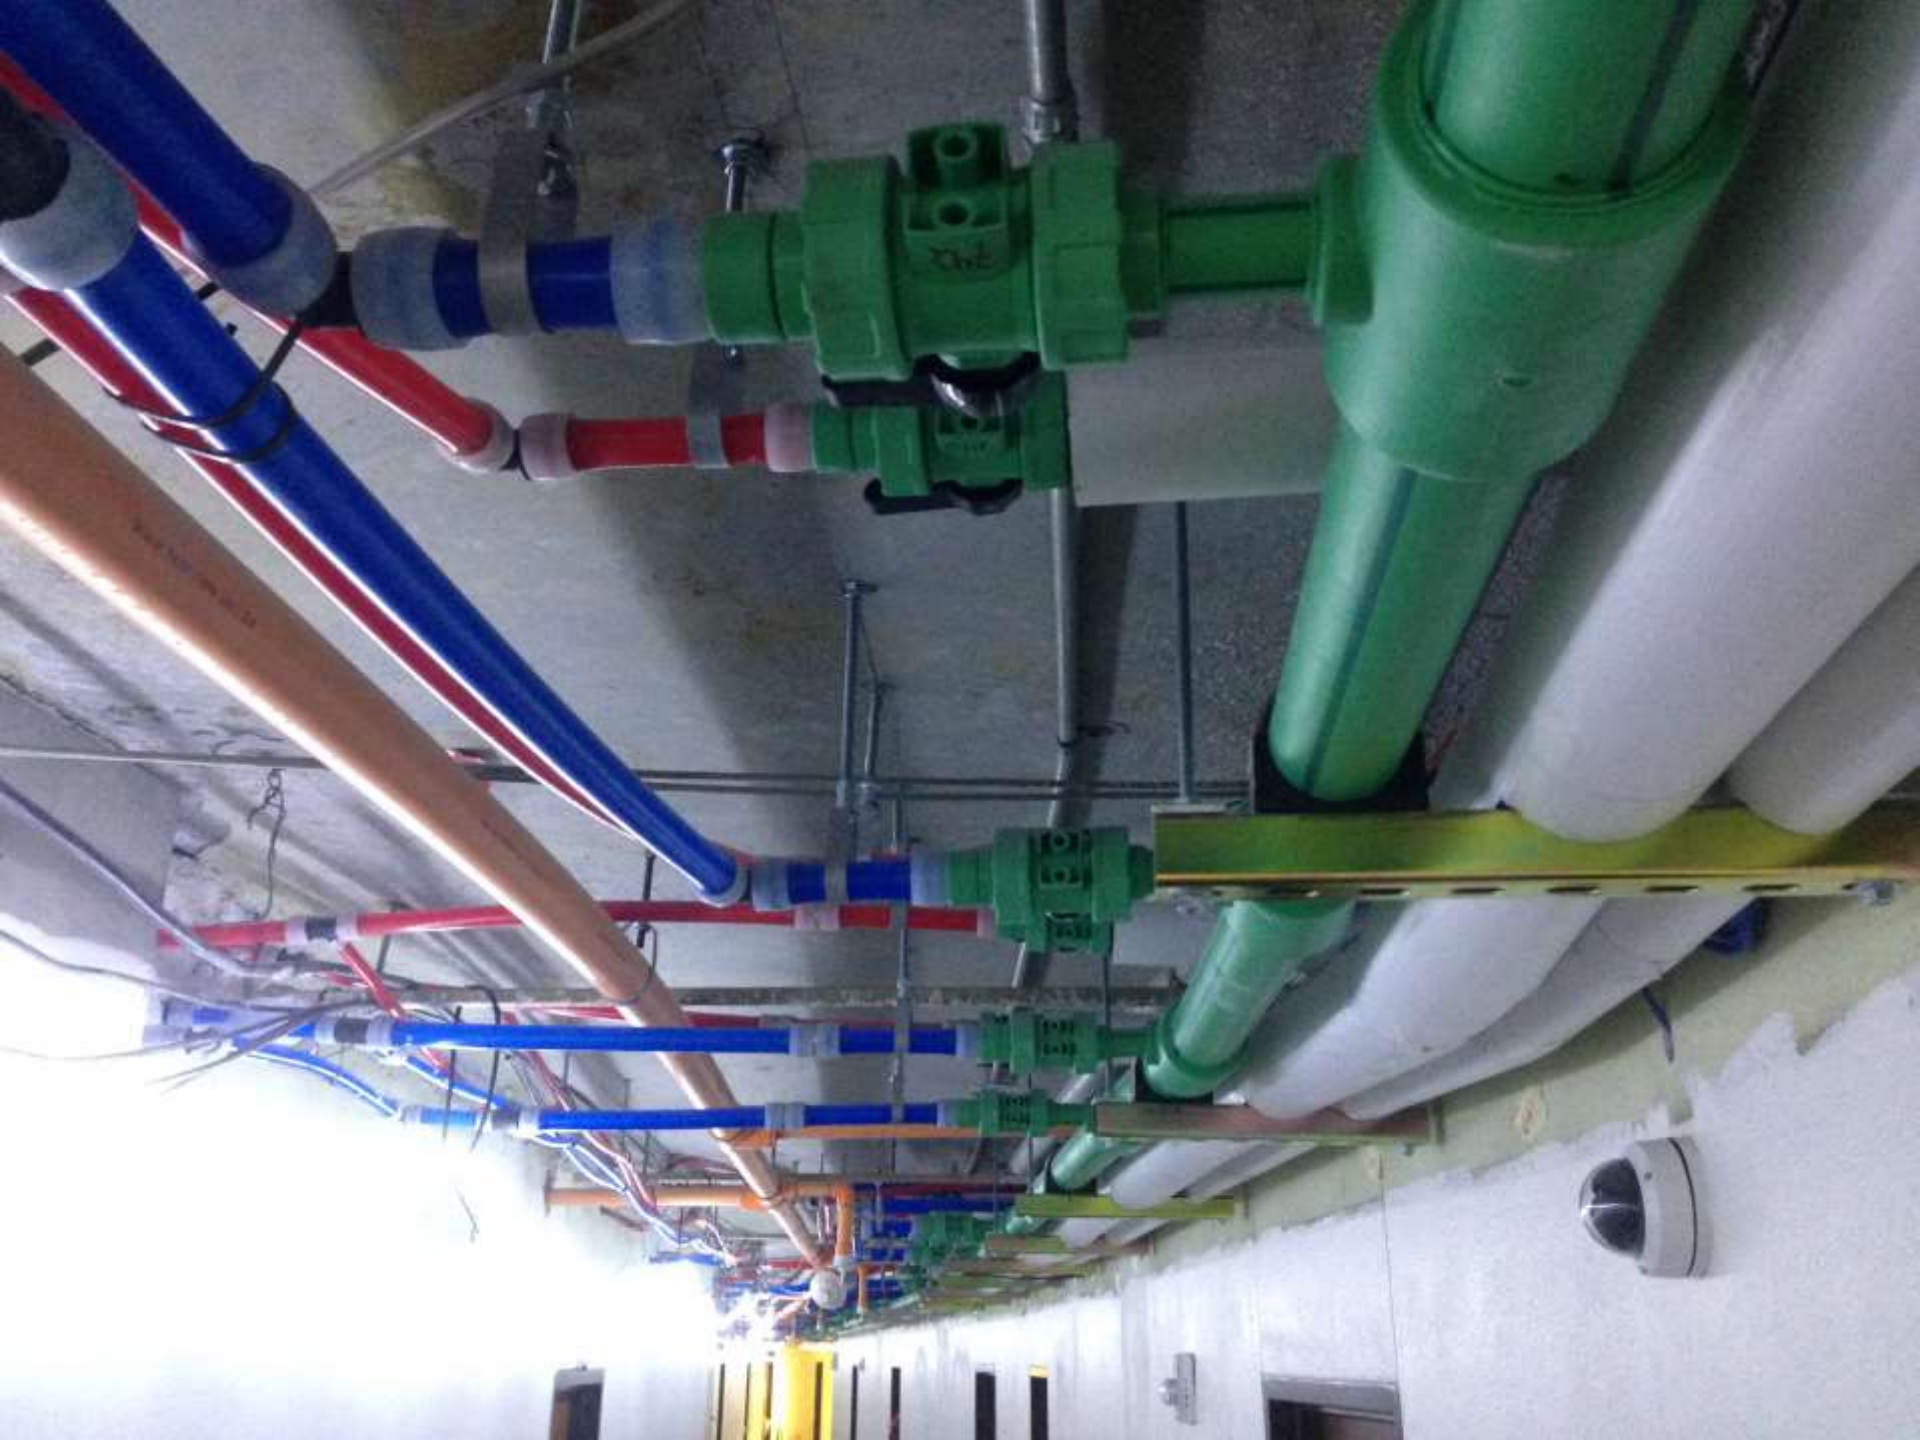
Dom water routing,  
isolating north from south

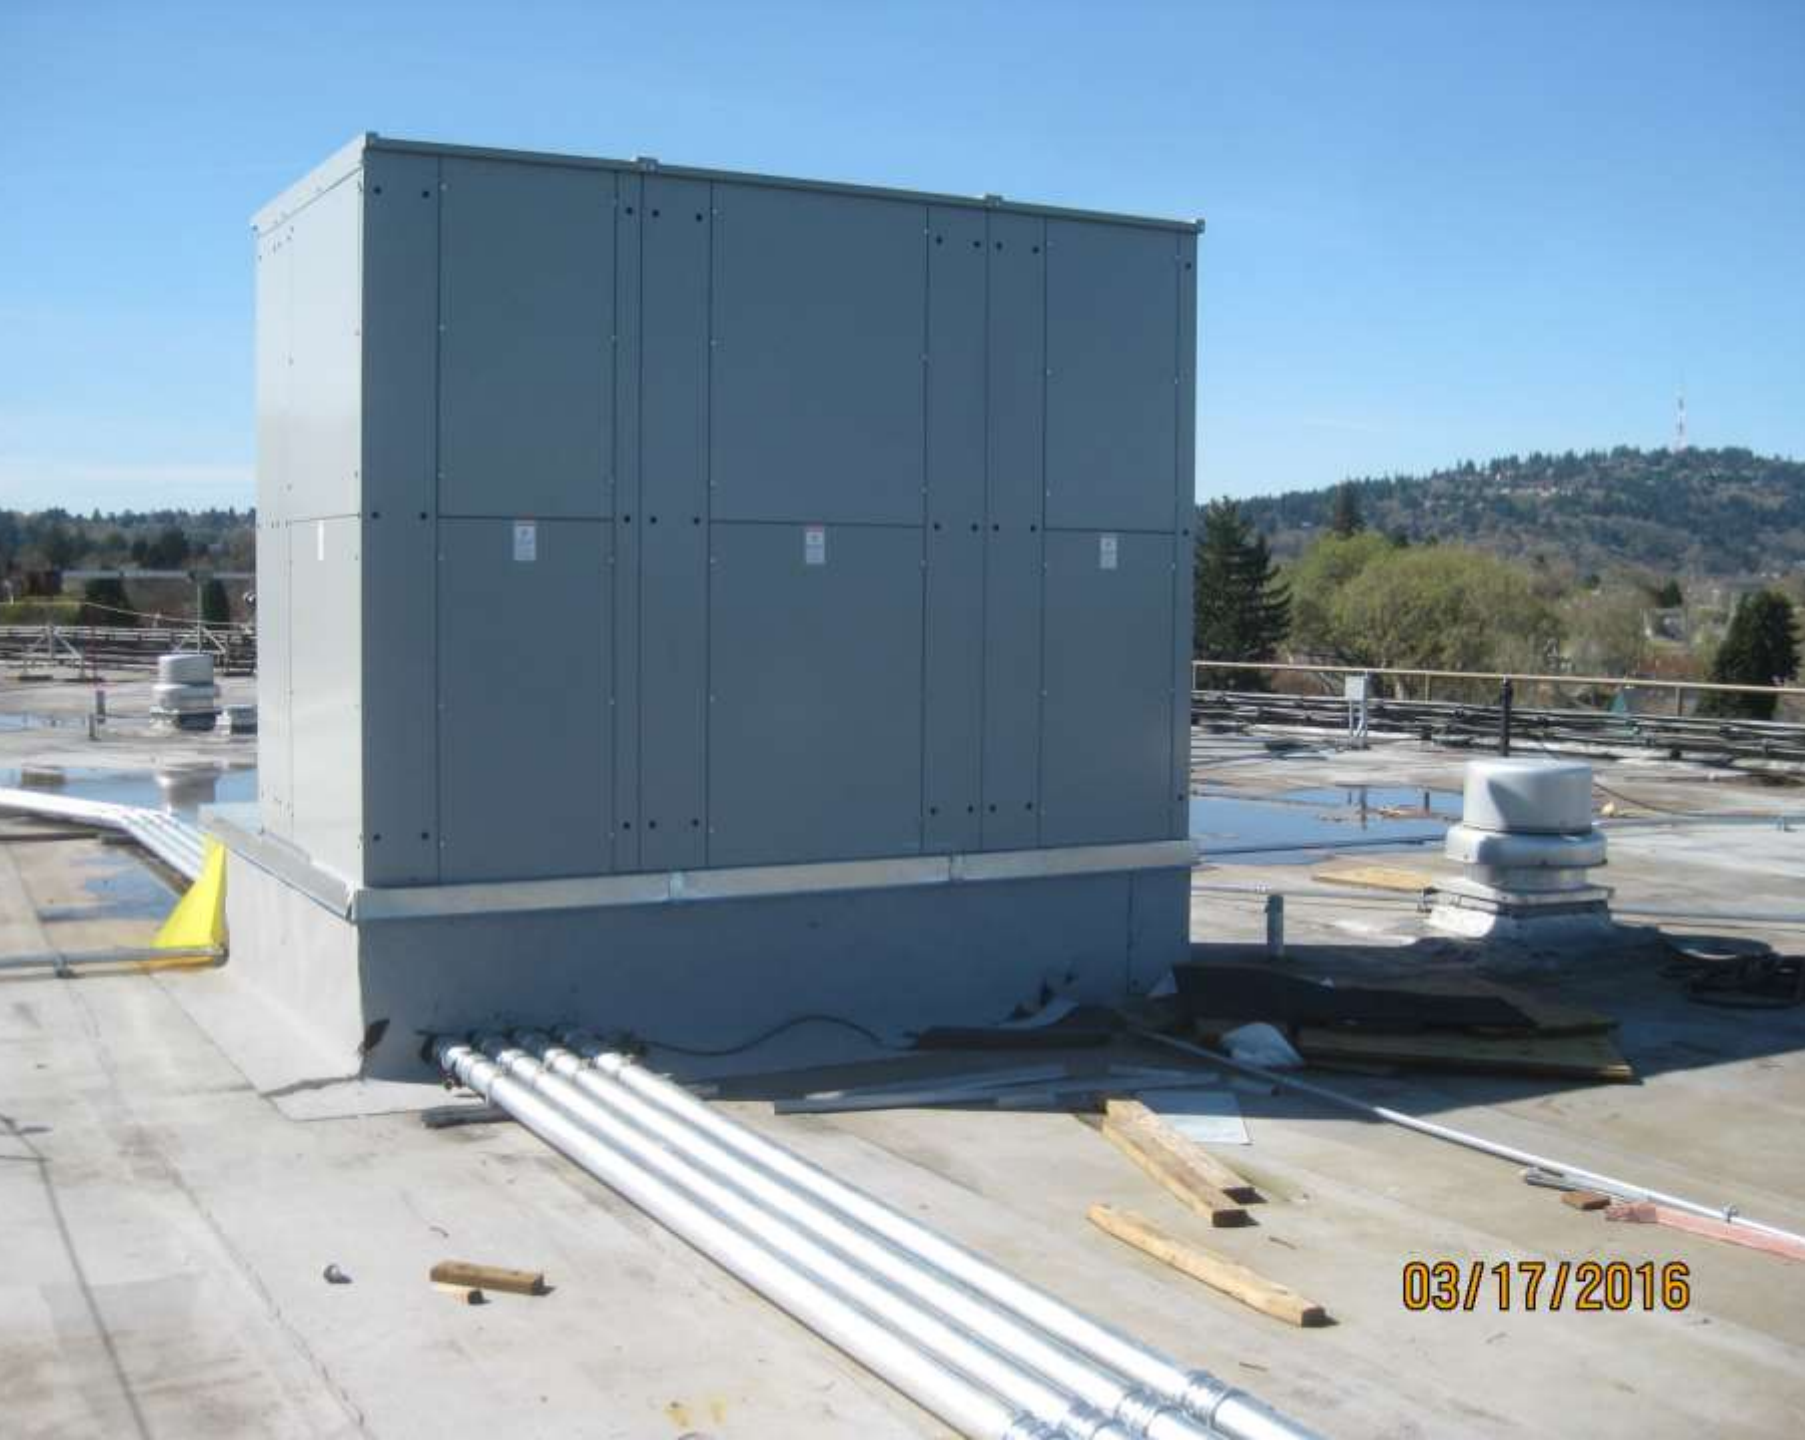
New 277/480vc Service  
for new HVAC
