**WESTMORELAND  
UNION MANOR**

**SENIOR HOUSING ENERGY  
RENOVATION**

## Westmoreland Union Manor – Building Design

# Mechanical Systems and Energy Modeling

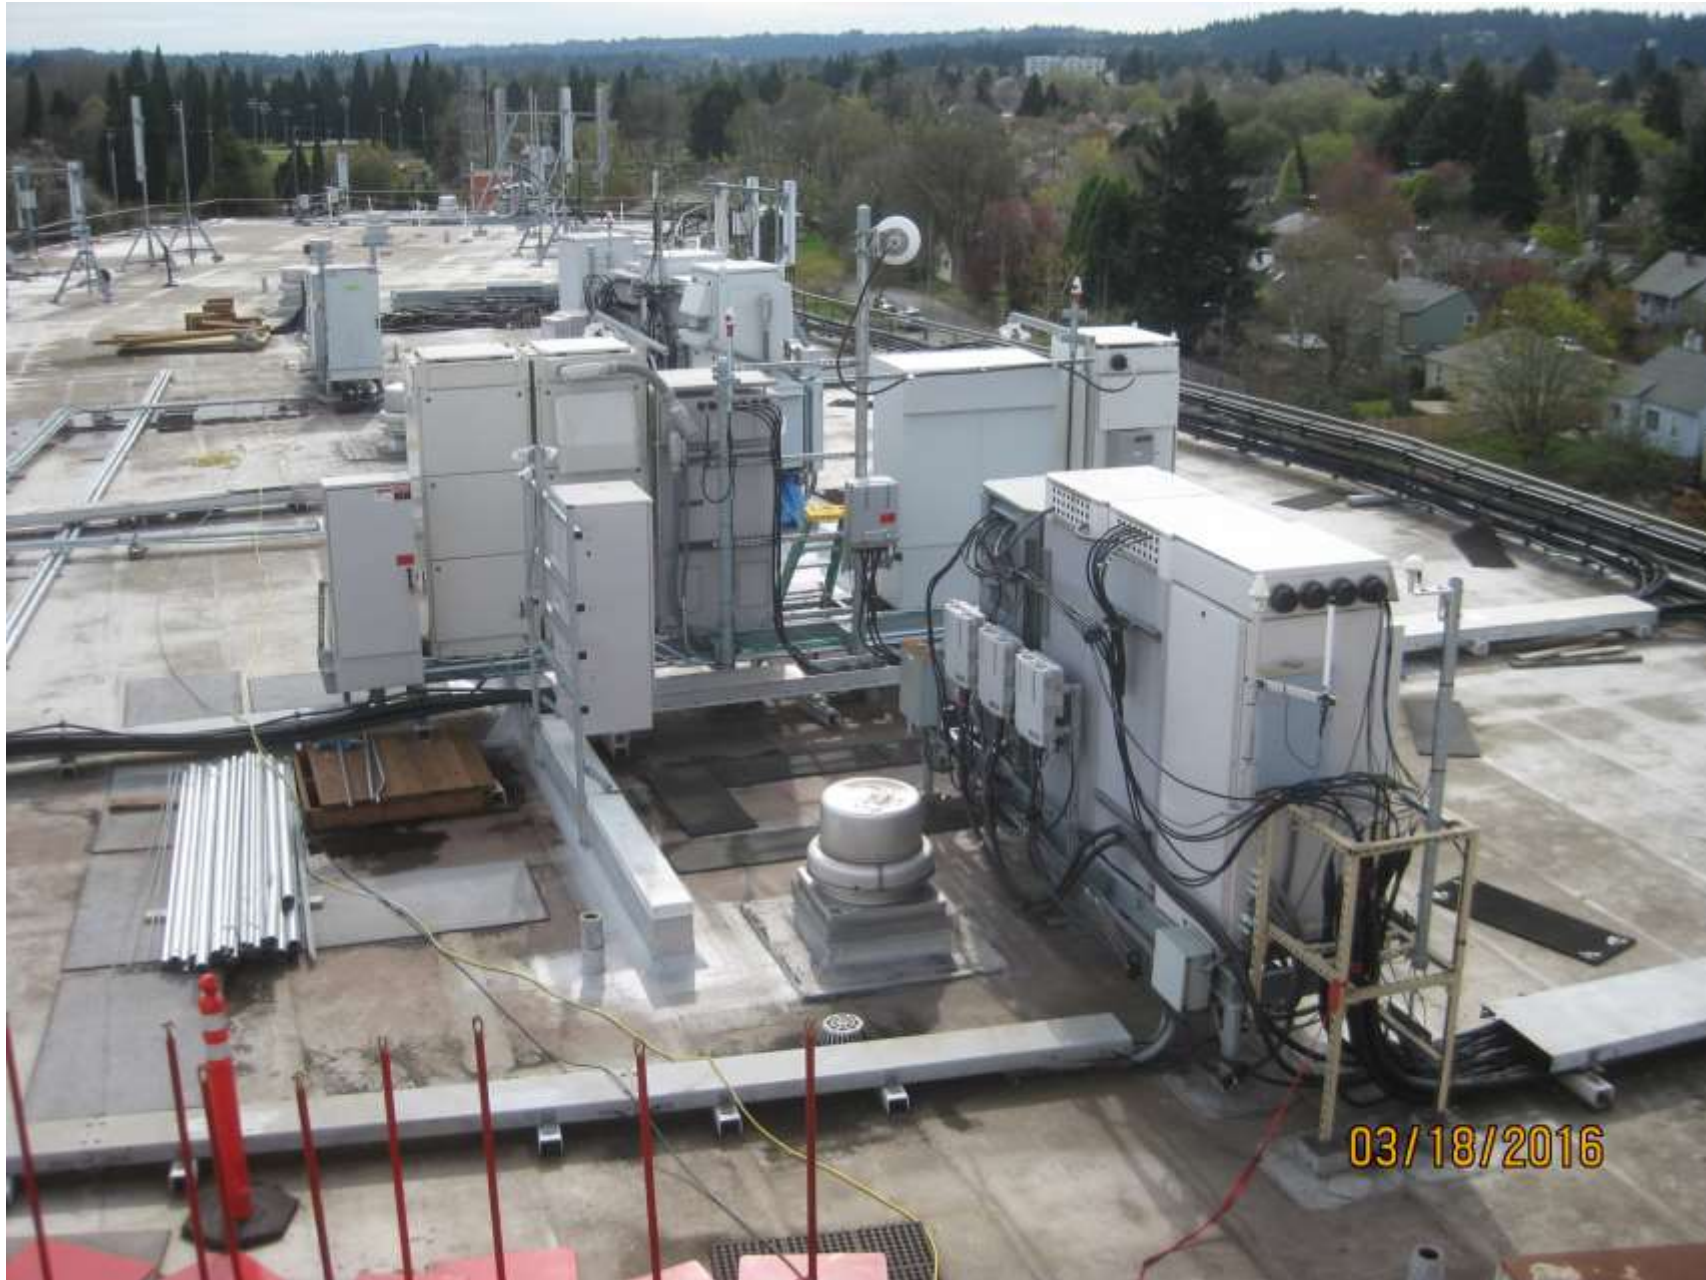
IFS Distribution and  
Transformer Gear  
to Service Mini-  
Split Heat Pumps  
per Unit

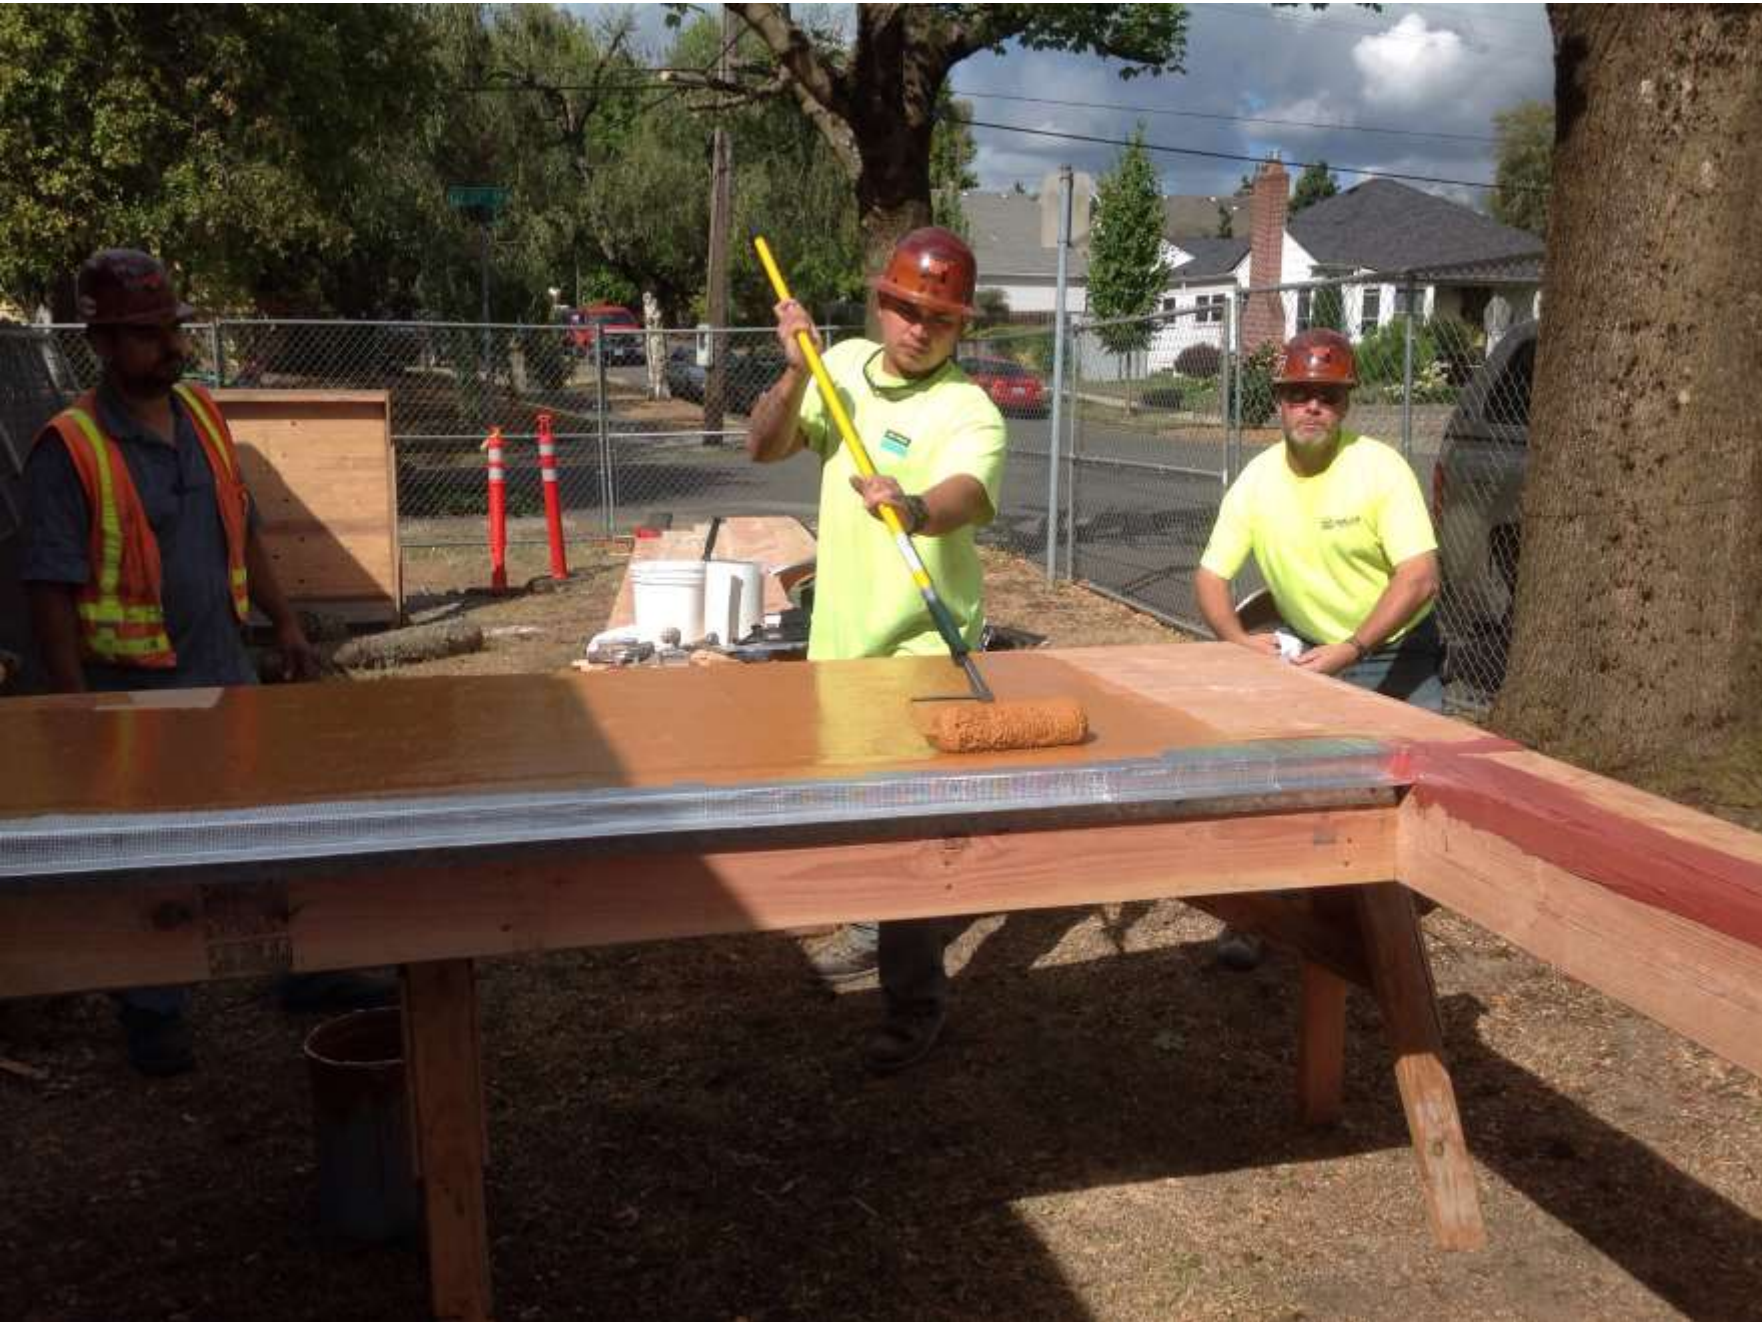
PT slab dogging embeds at columns

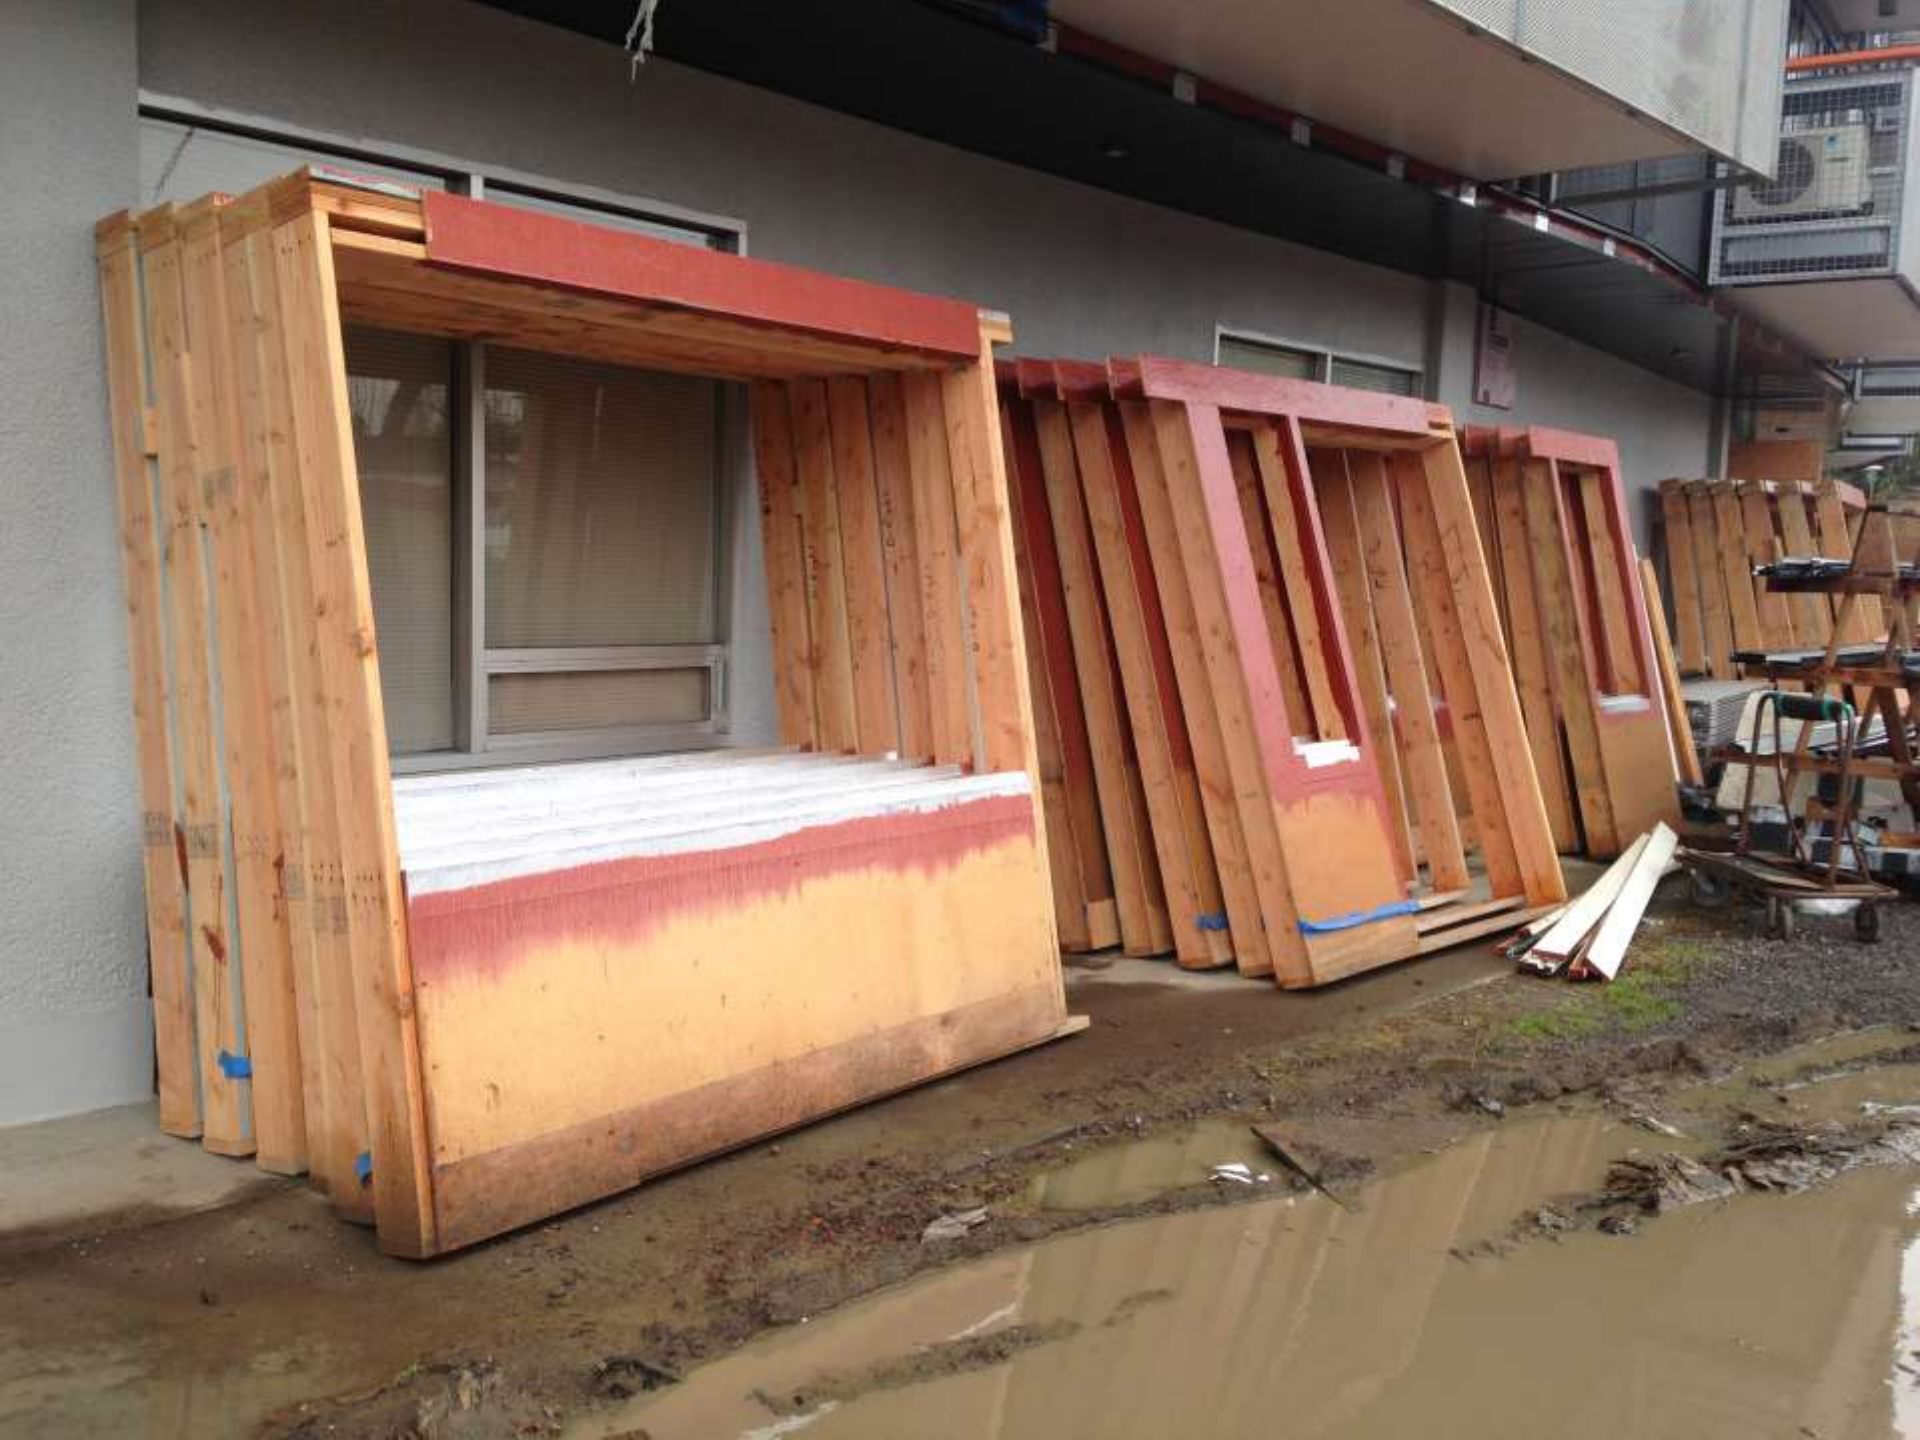
Wall Fabrication  
And  
Pre-Application of  
WRB

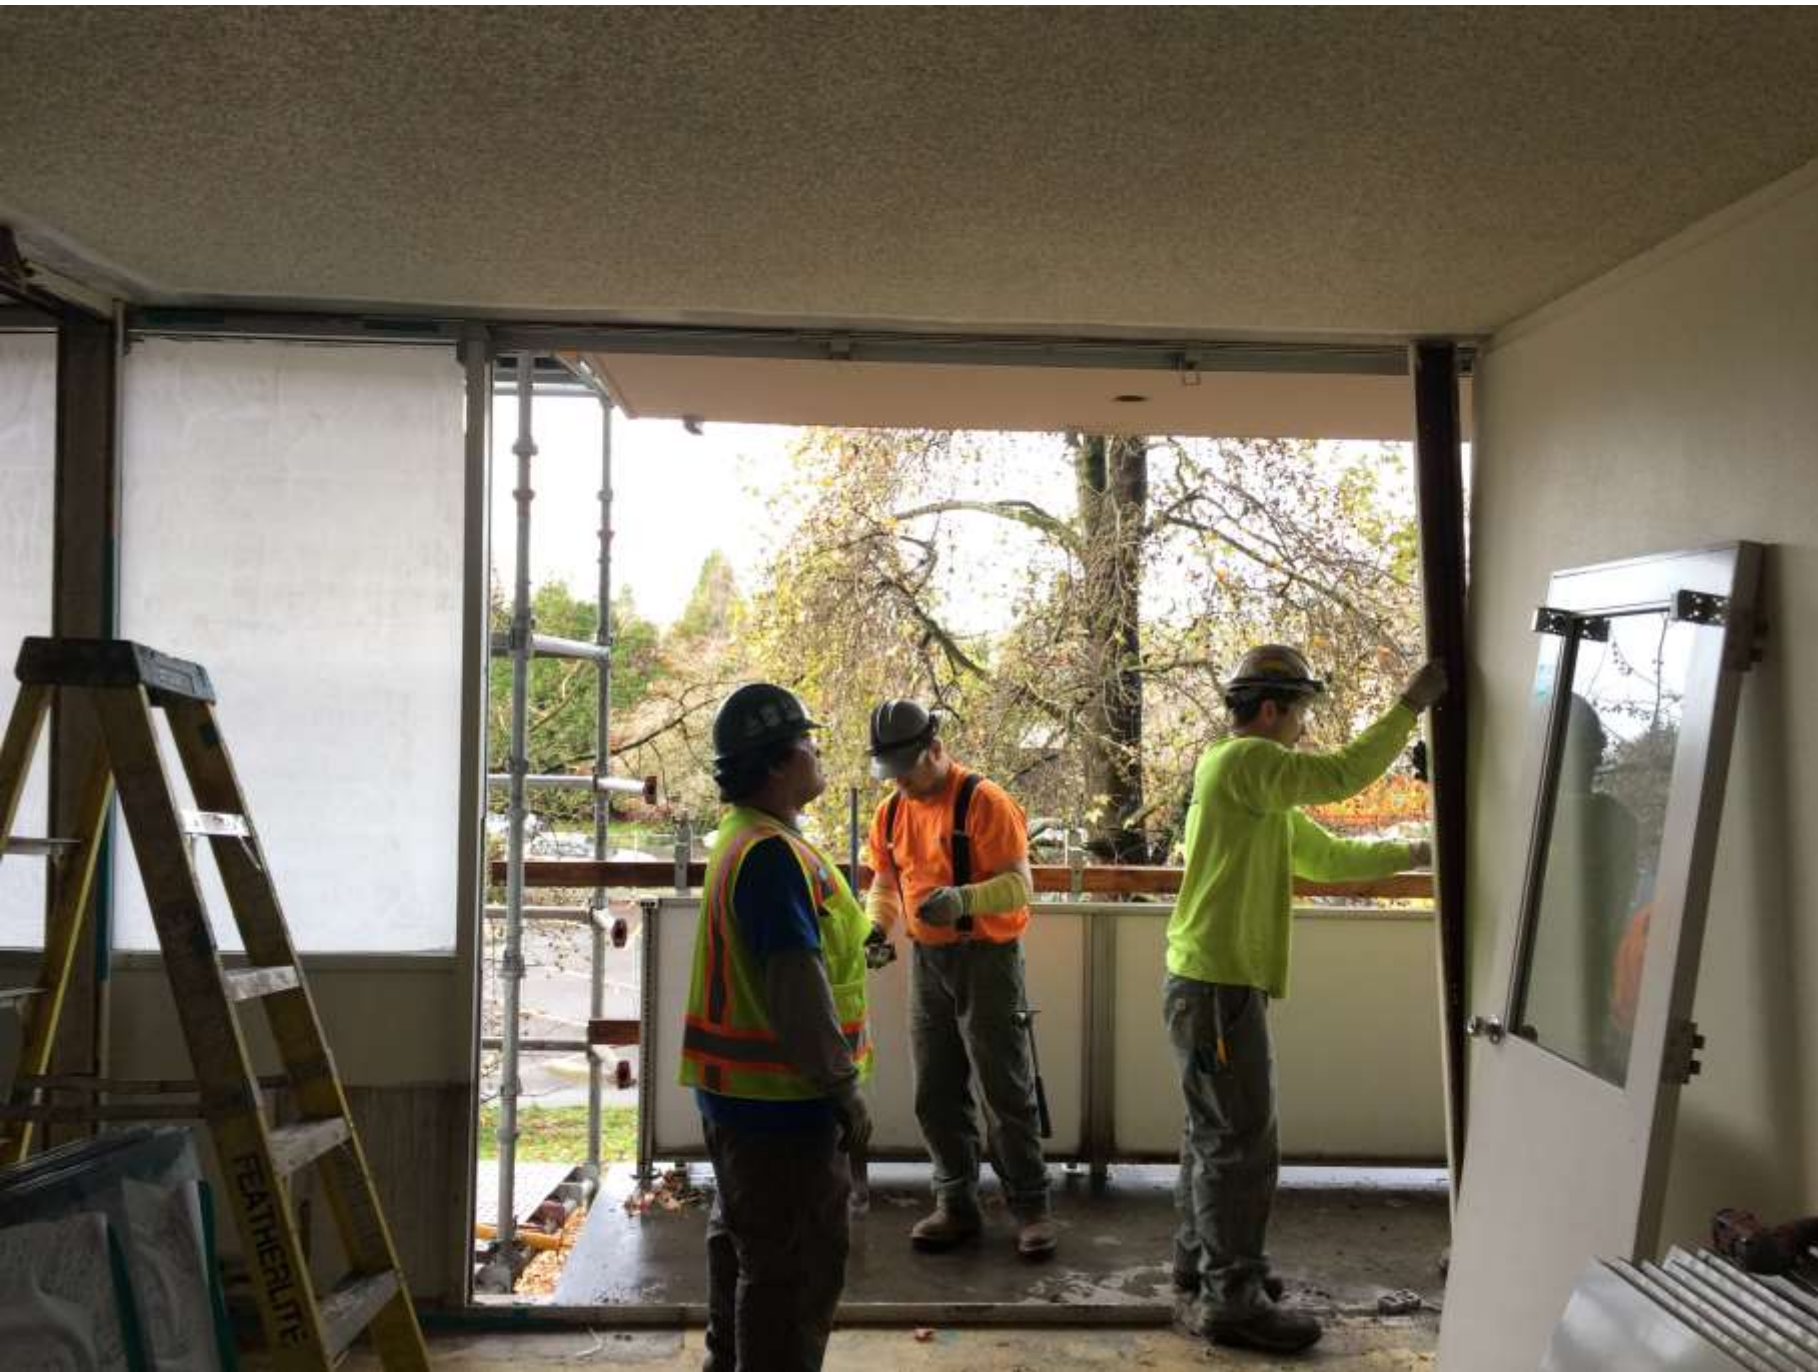
“Flying” Walls into Place as  
Demo Precedes per Floor

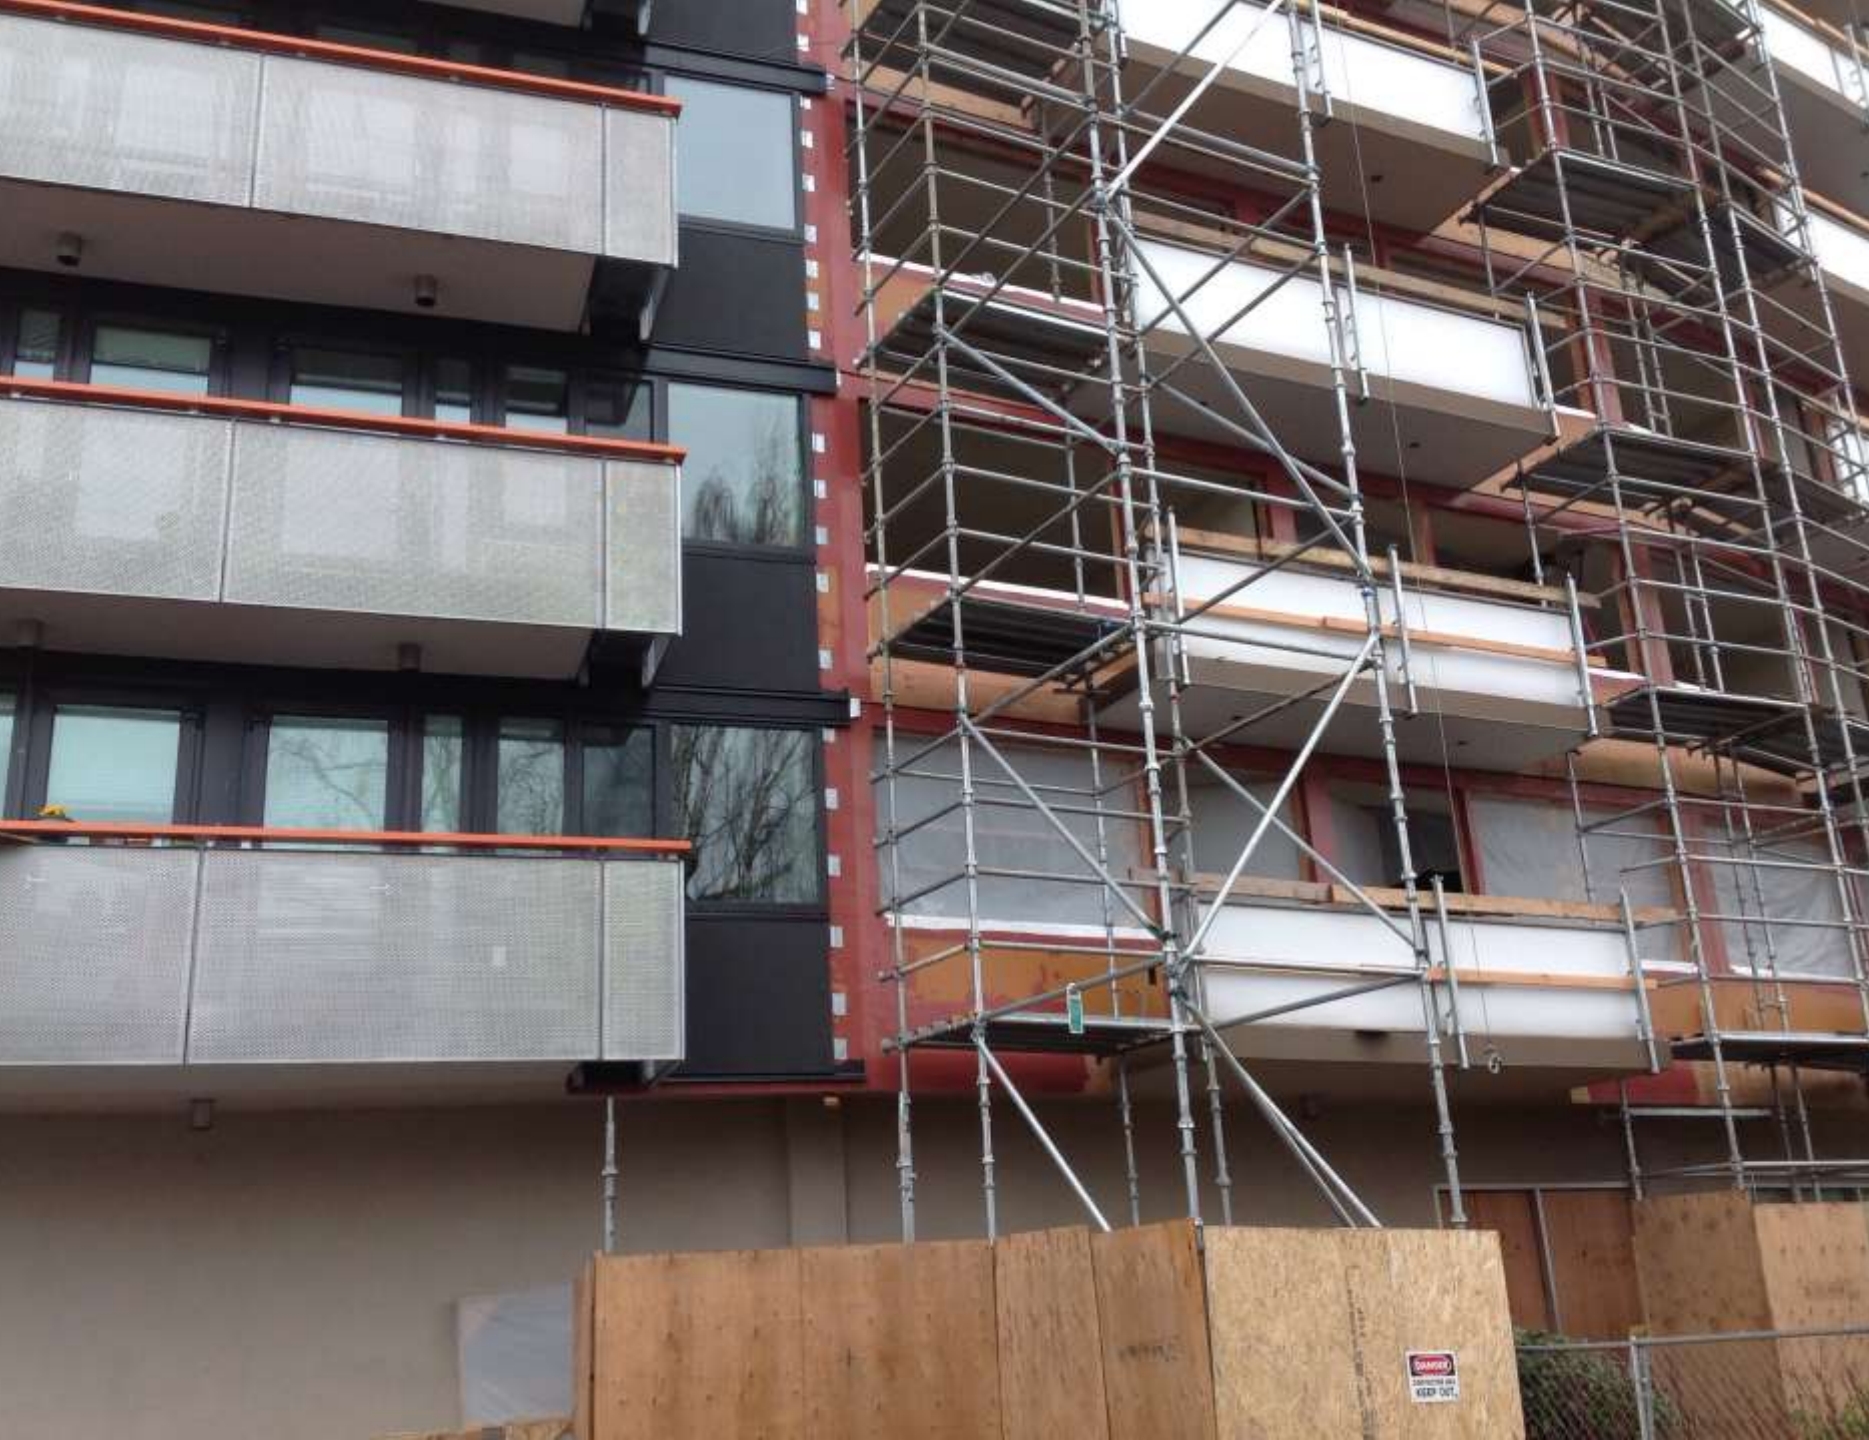
Walls Installed and Made  
Weather-Tight If Inclement  
Weather Anticipated

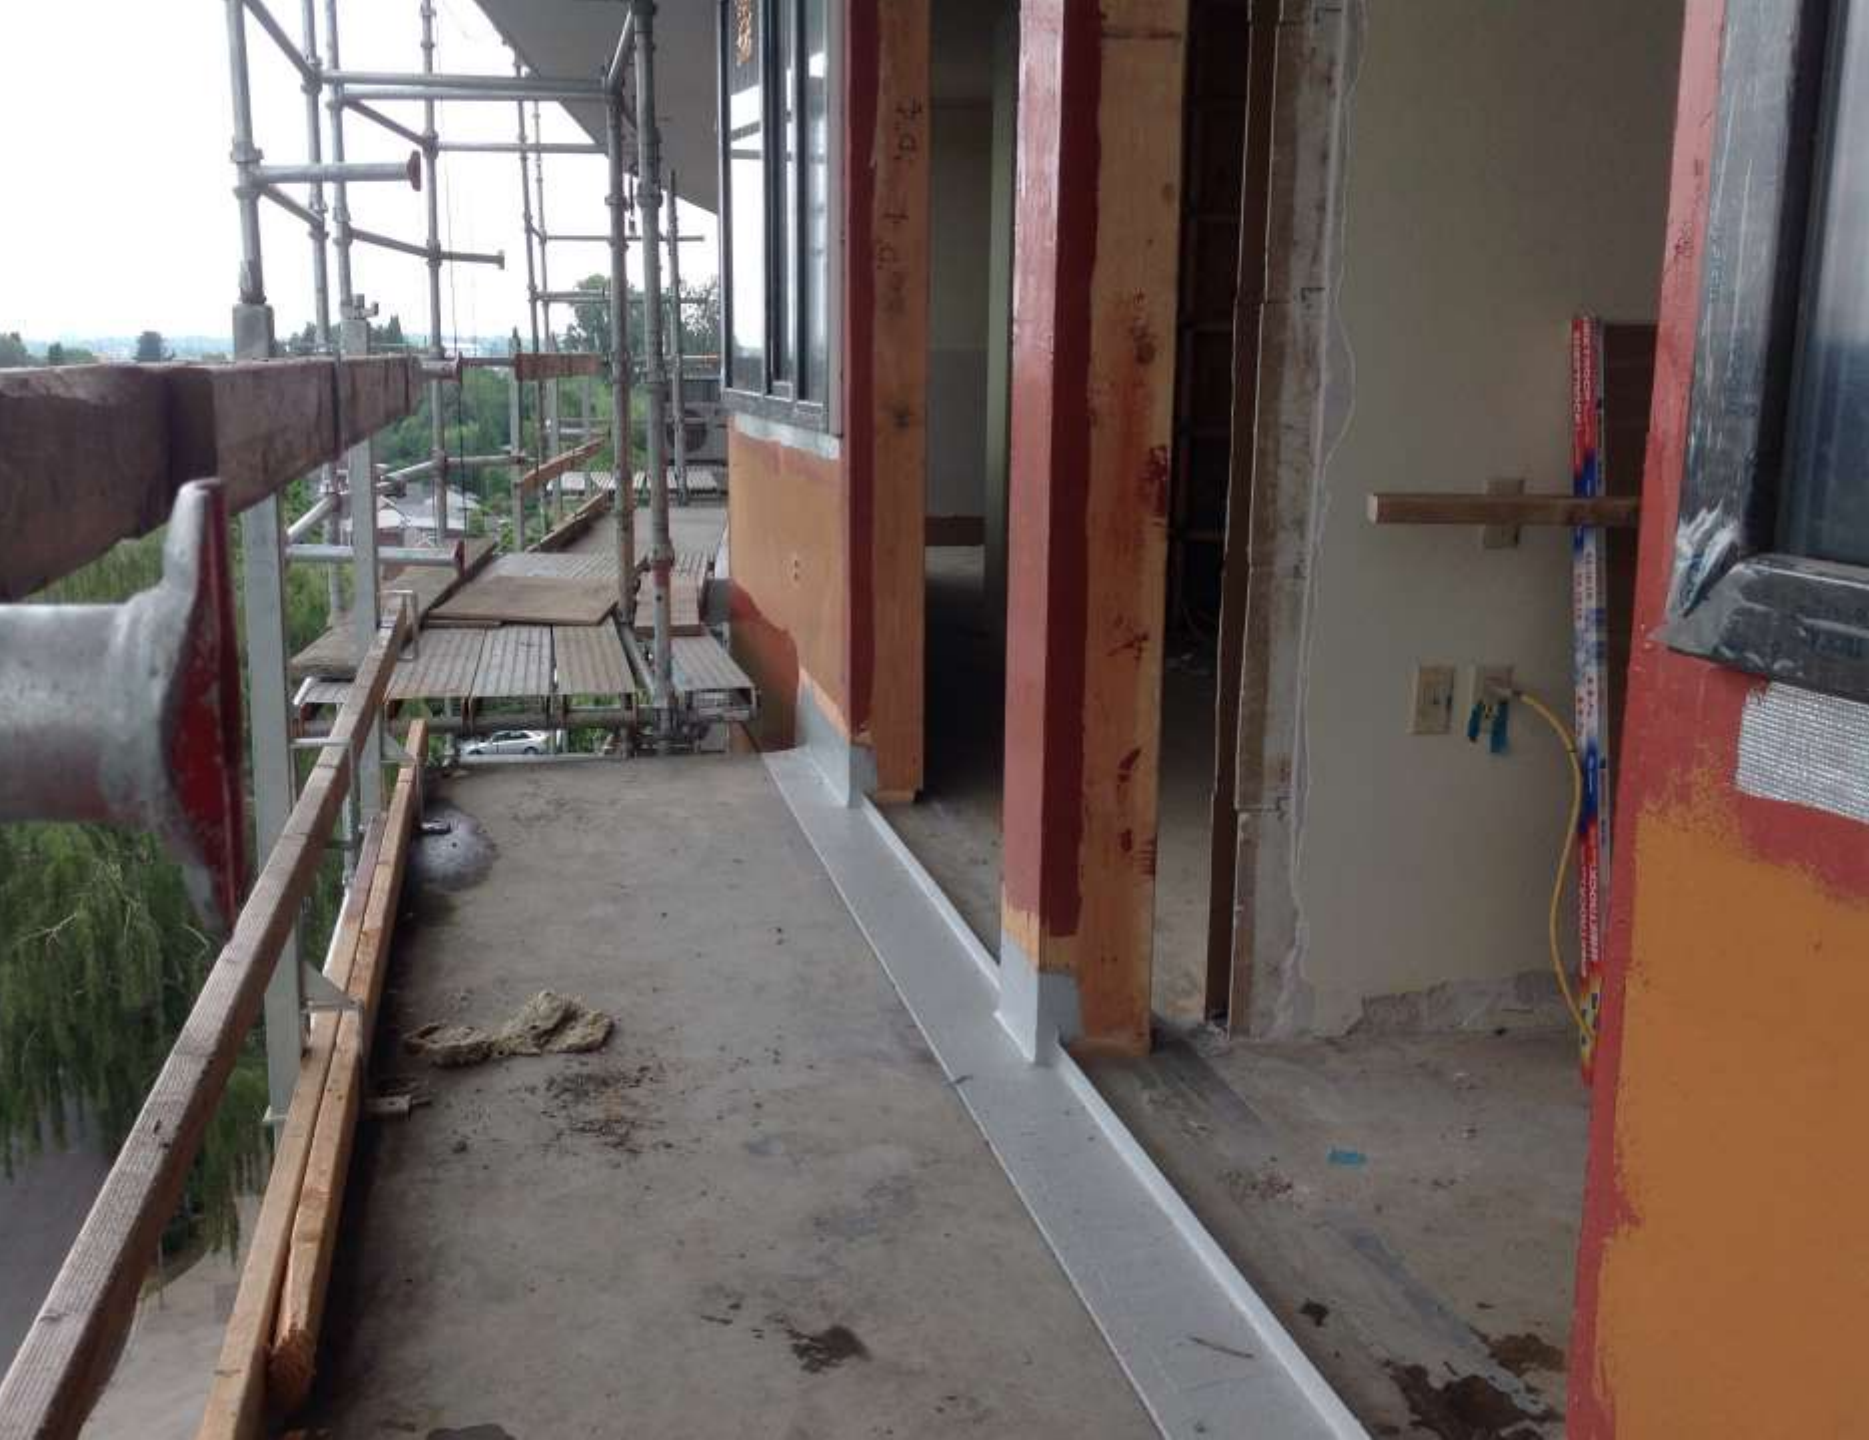
Temporary  
closure of doors  
& windows for  
weather

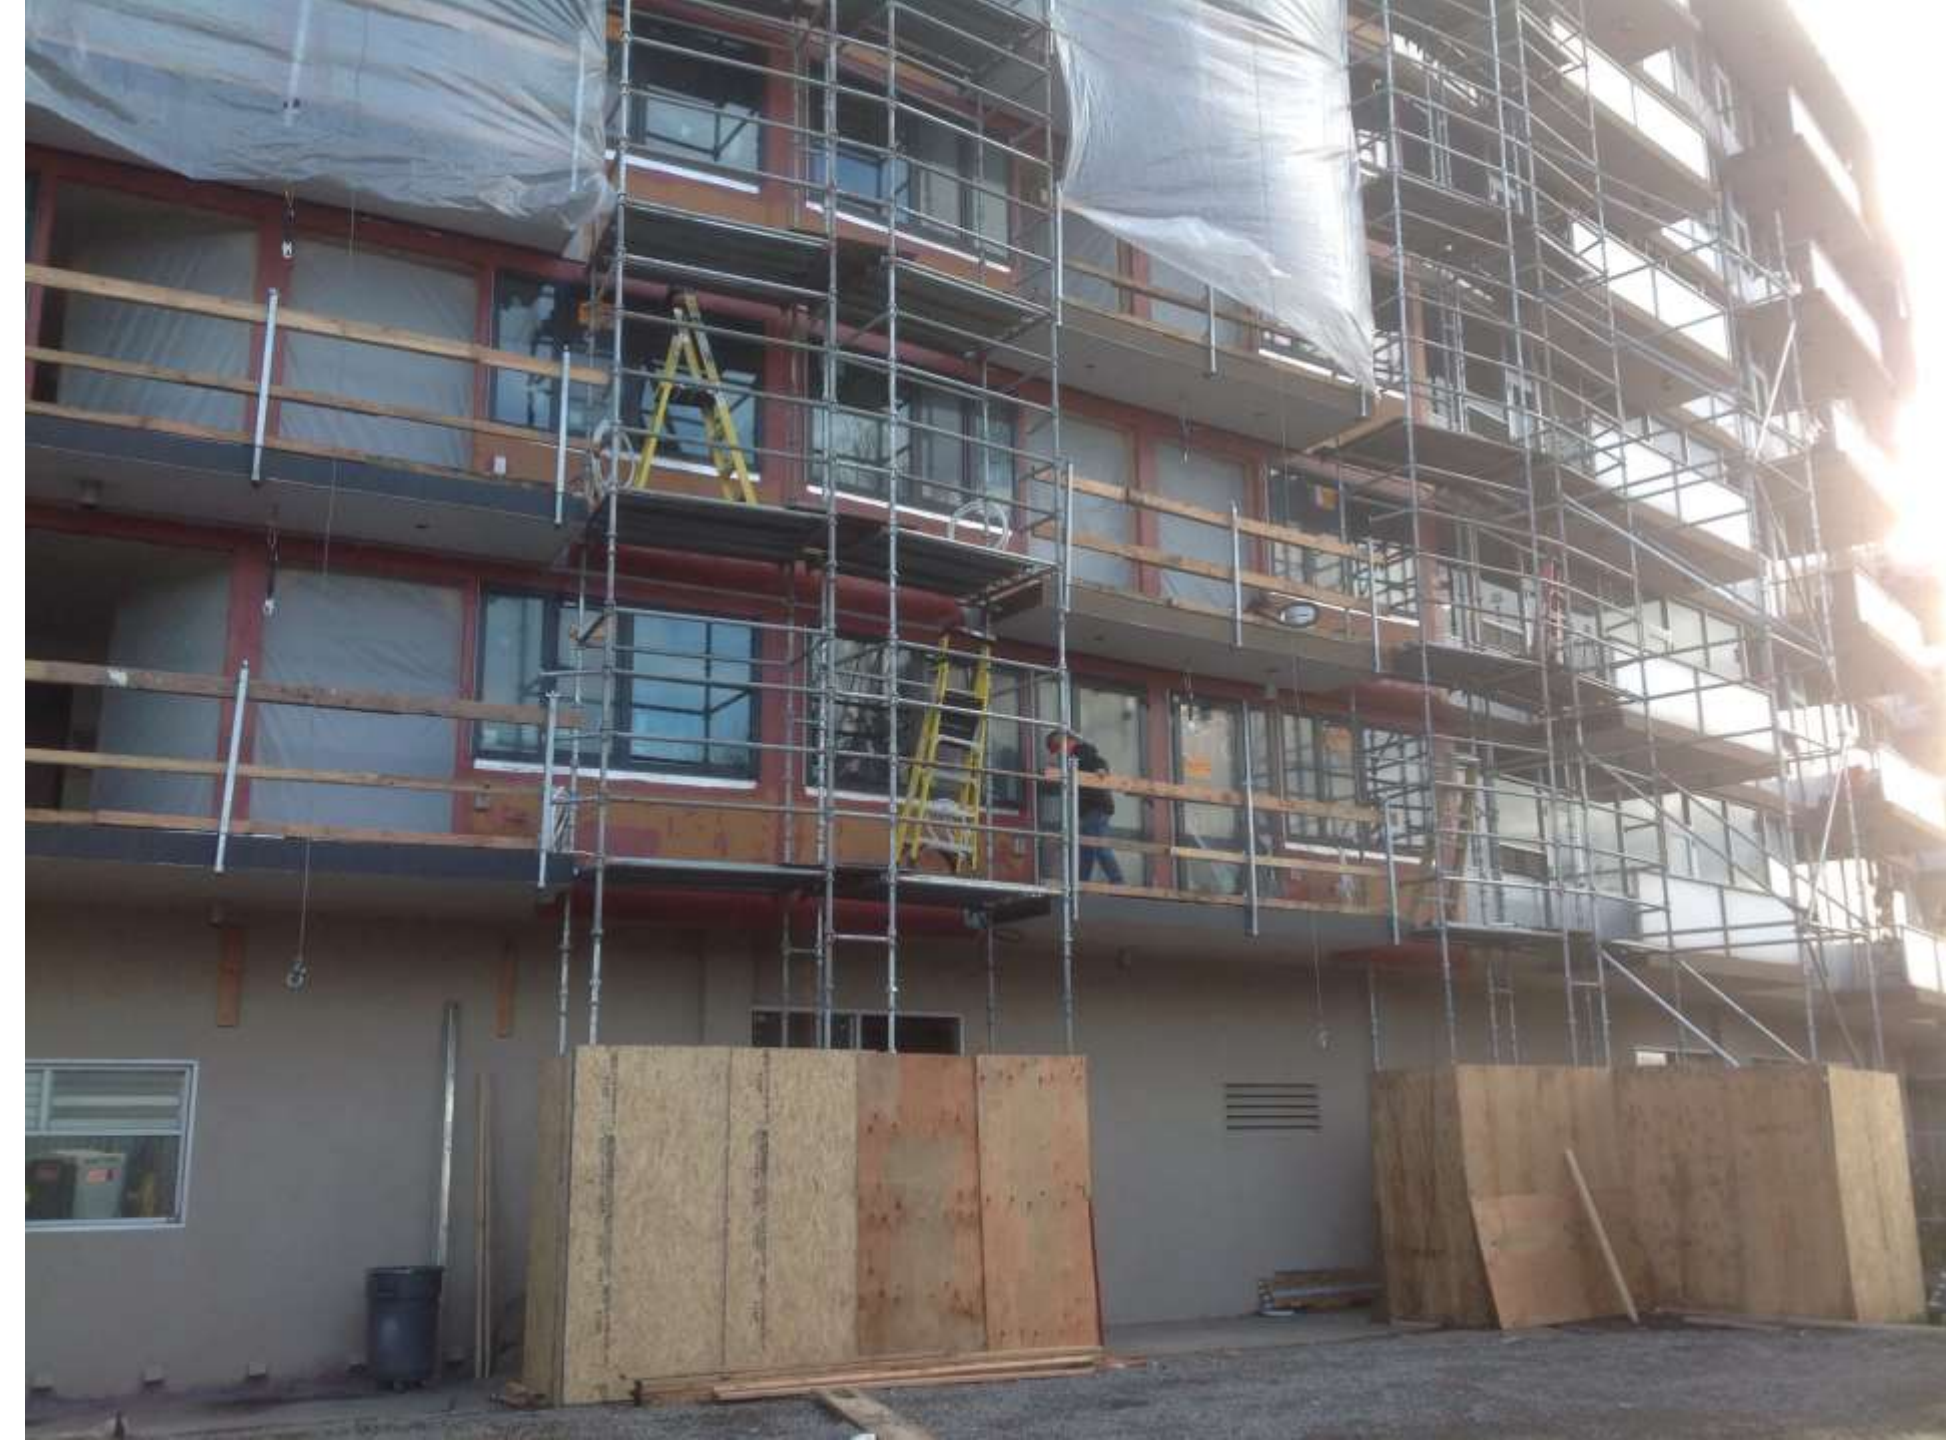
Water-  
proofing at  
Concrete Decks  
Interfaced with  
Wall Framing,  
Sheathing, & Back  
Dam  
– 96 hr. Cure Time

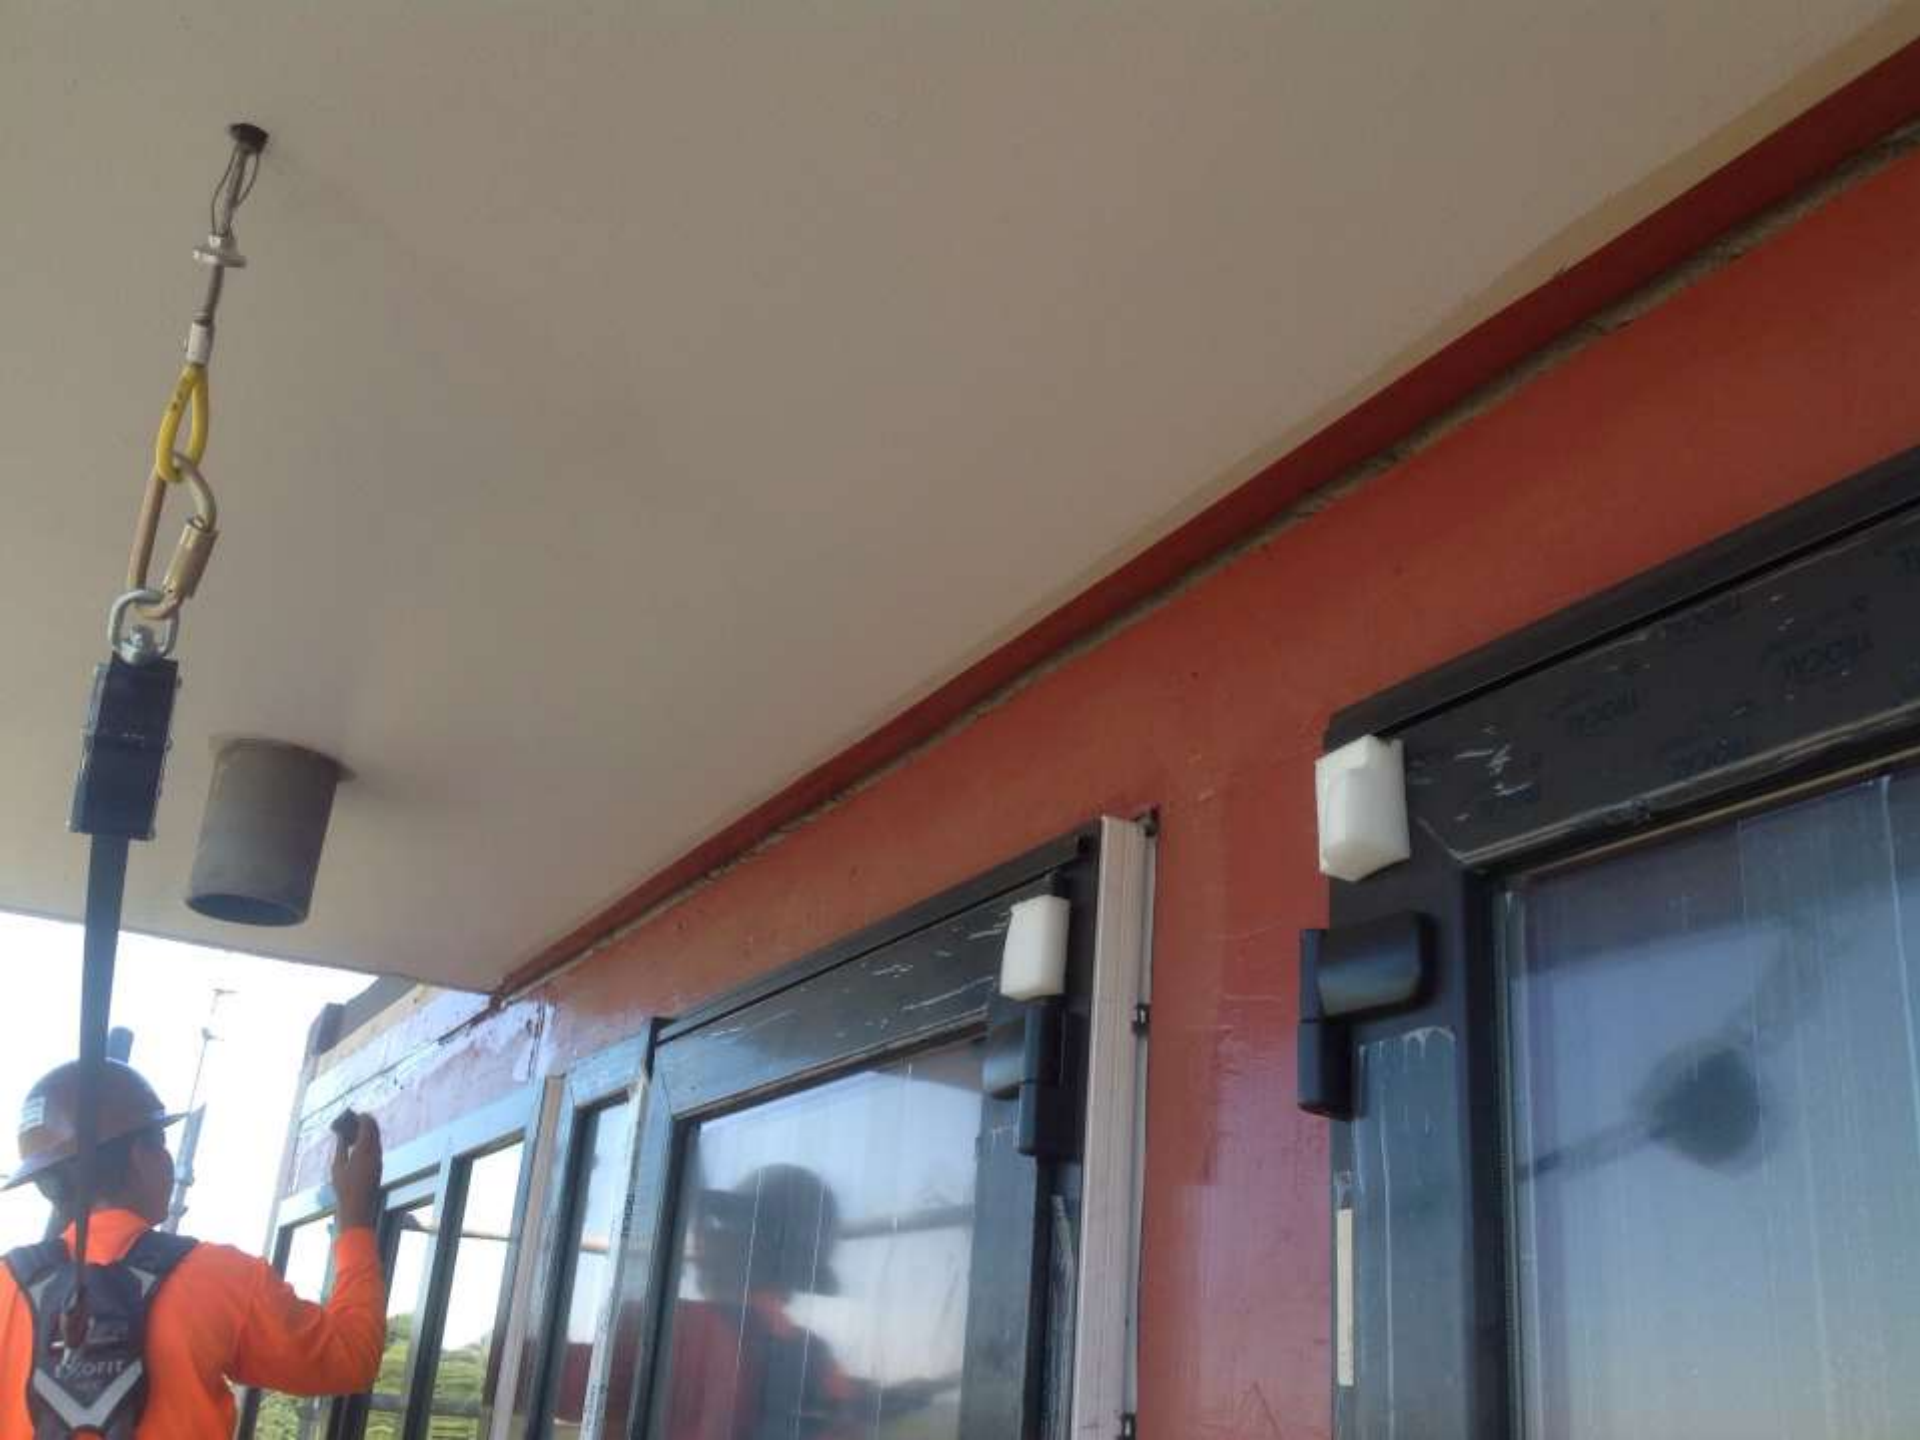
Exterior Glazing  
and Doors  
Installed,  
Cladding &  
Metal Staged
