**WESTMORELAND  
UNION MANOR**

**SENIOR HOUSING ENERGY  
RENOVATION**

## Westmoreland Union Manor – Building Design

# Mechanical Systems and Energy Modeling

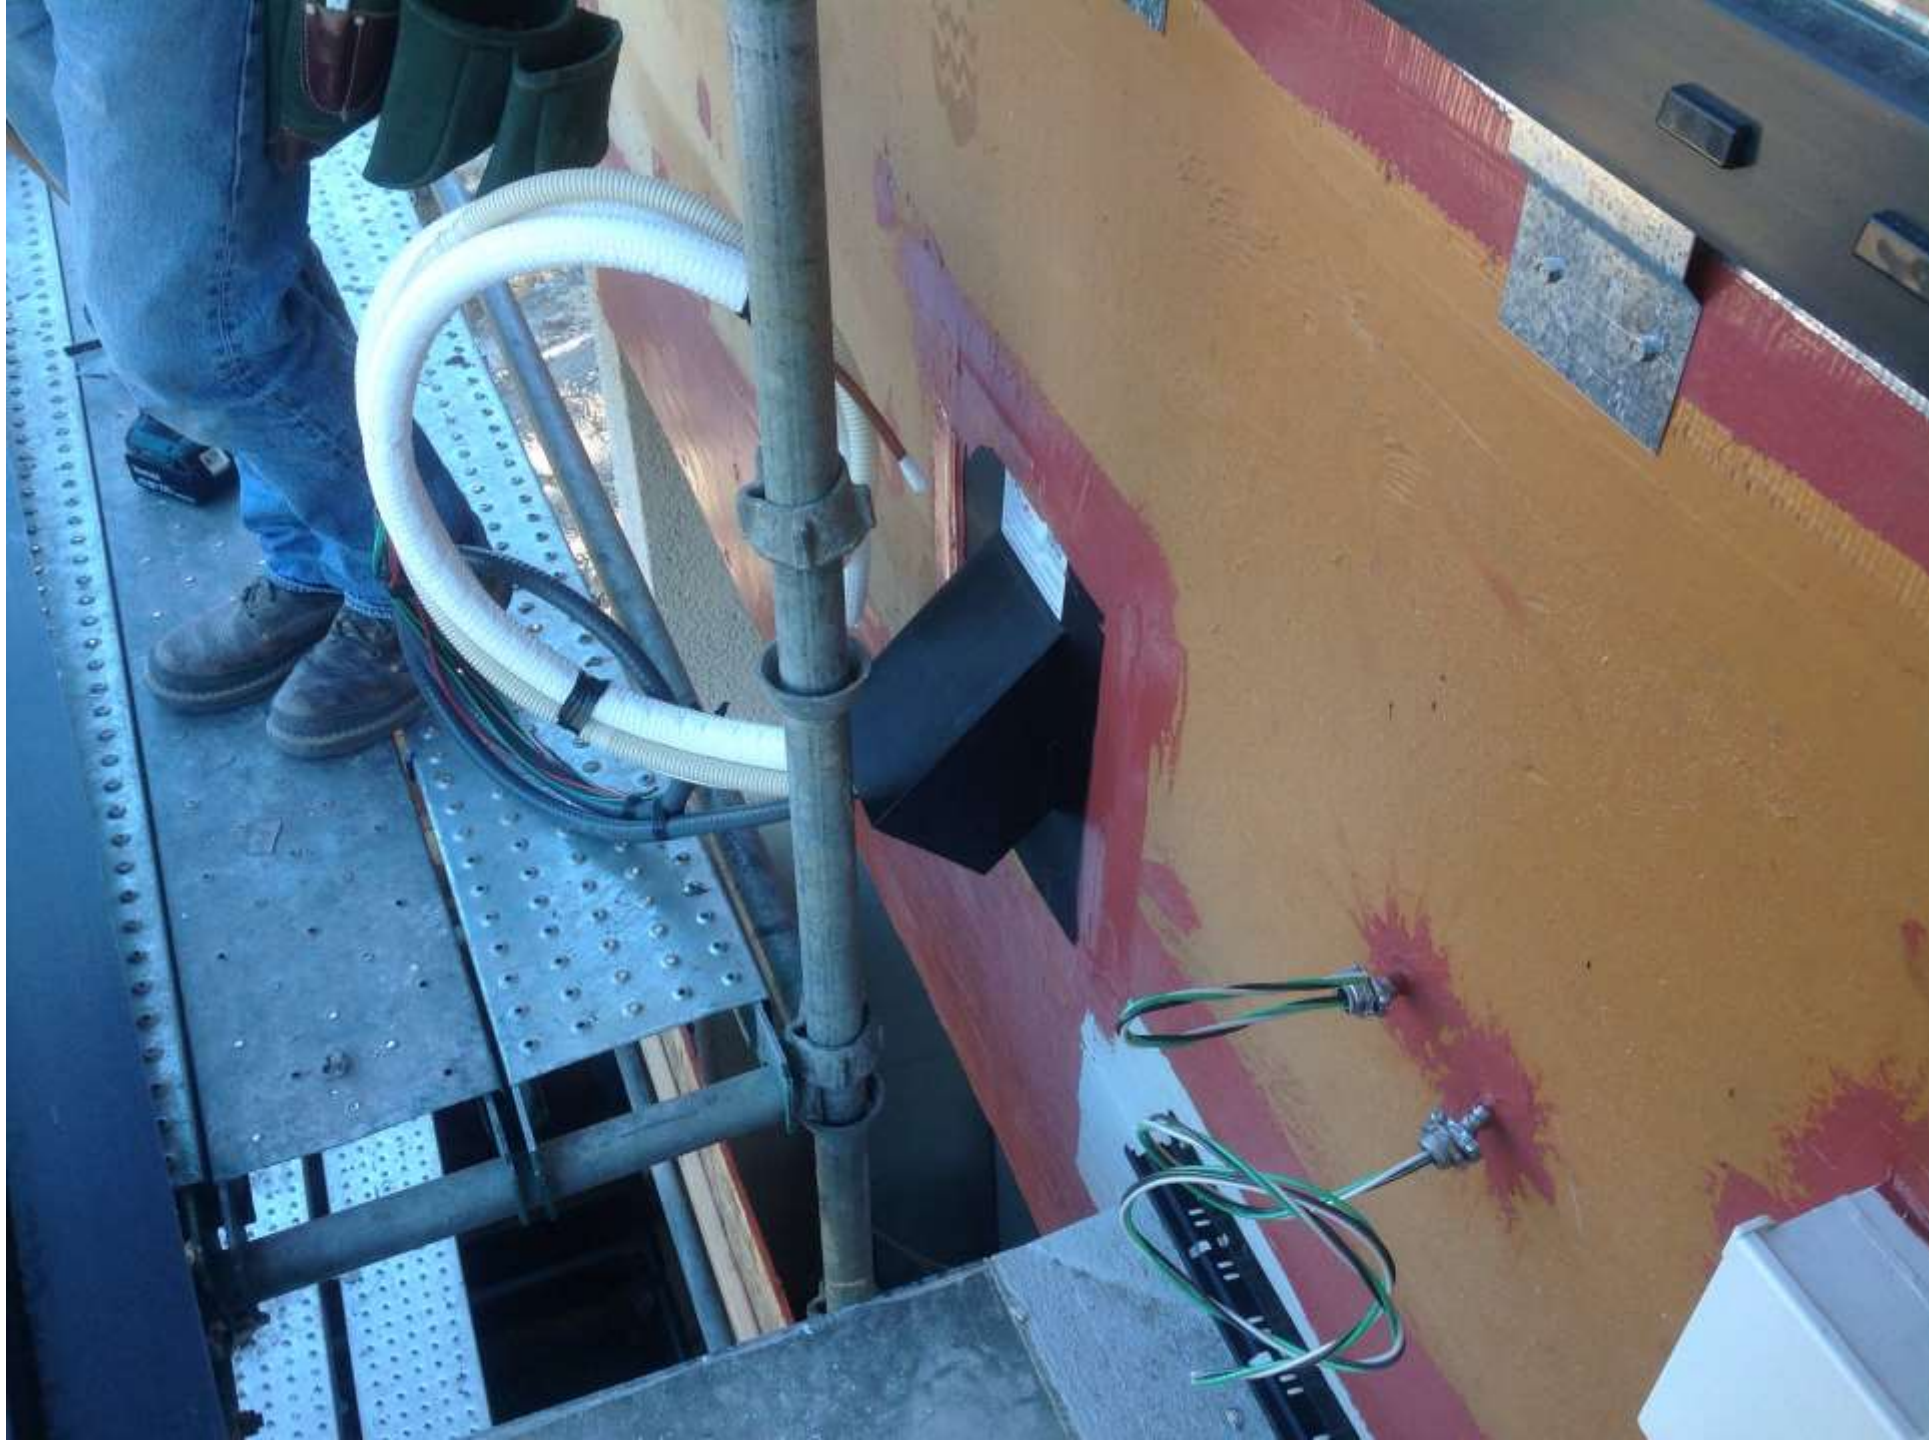
MEP Penetrations

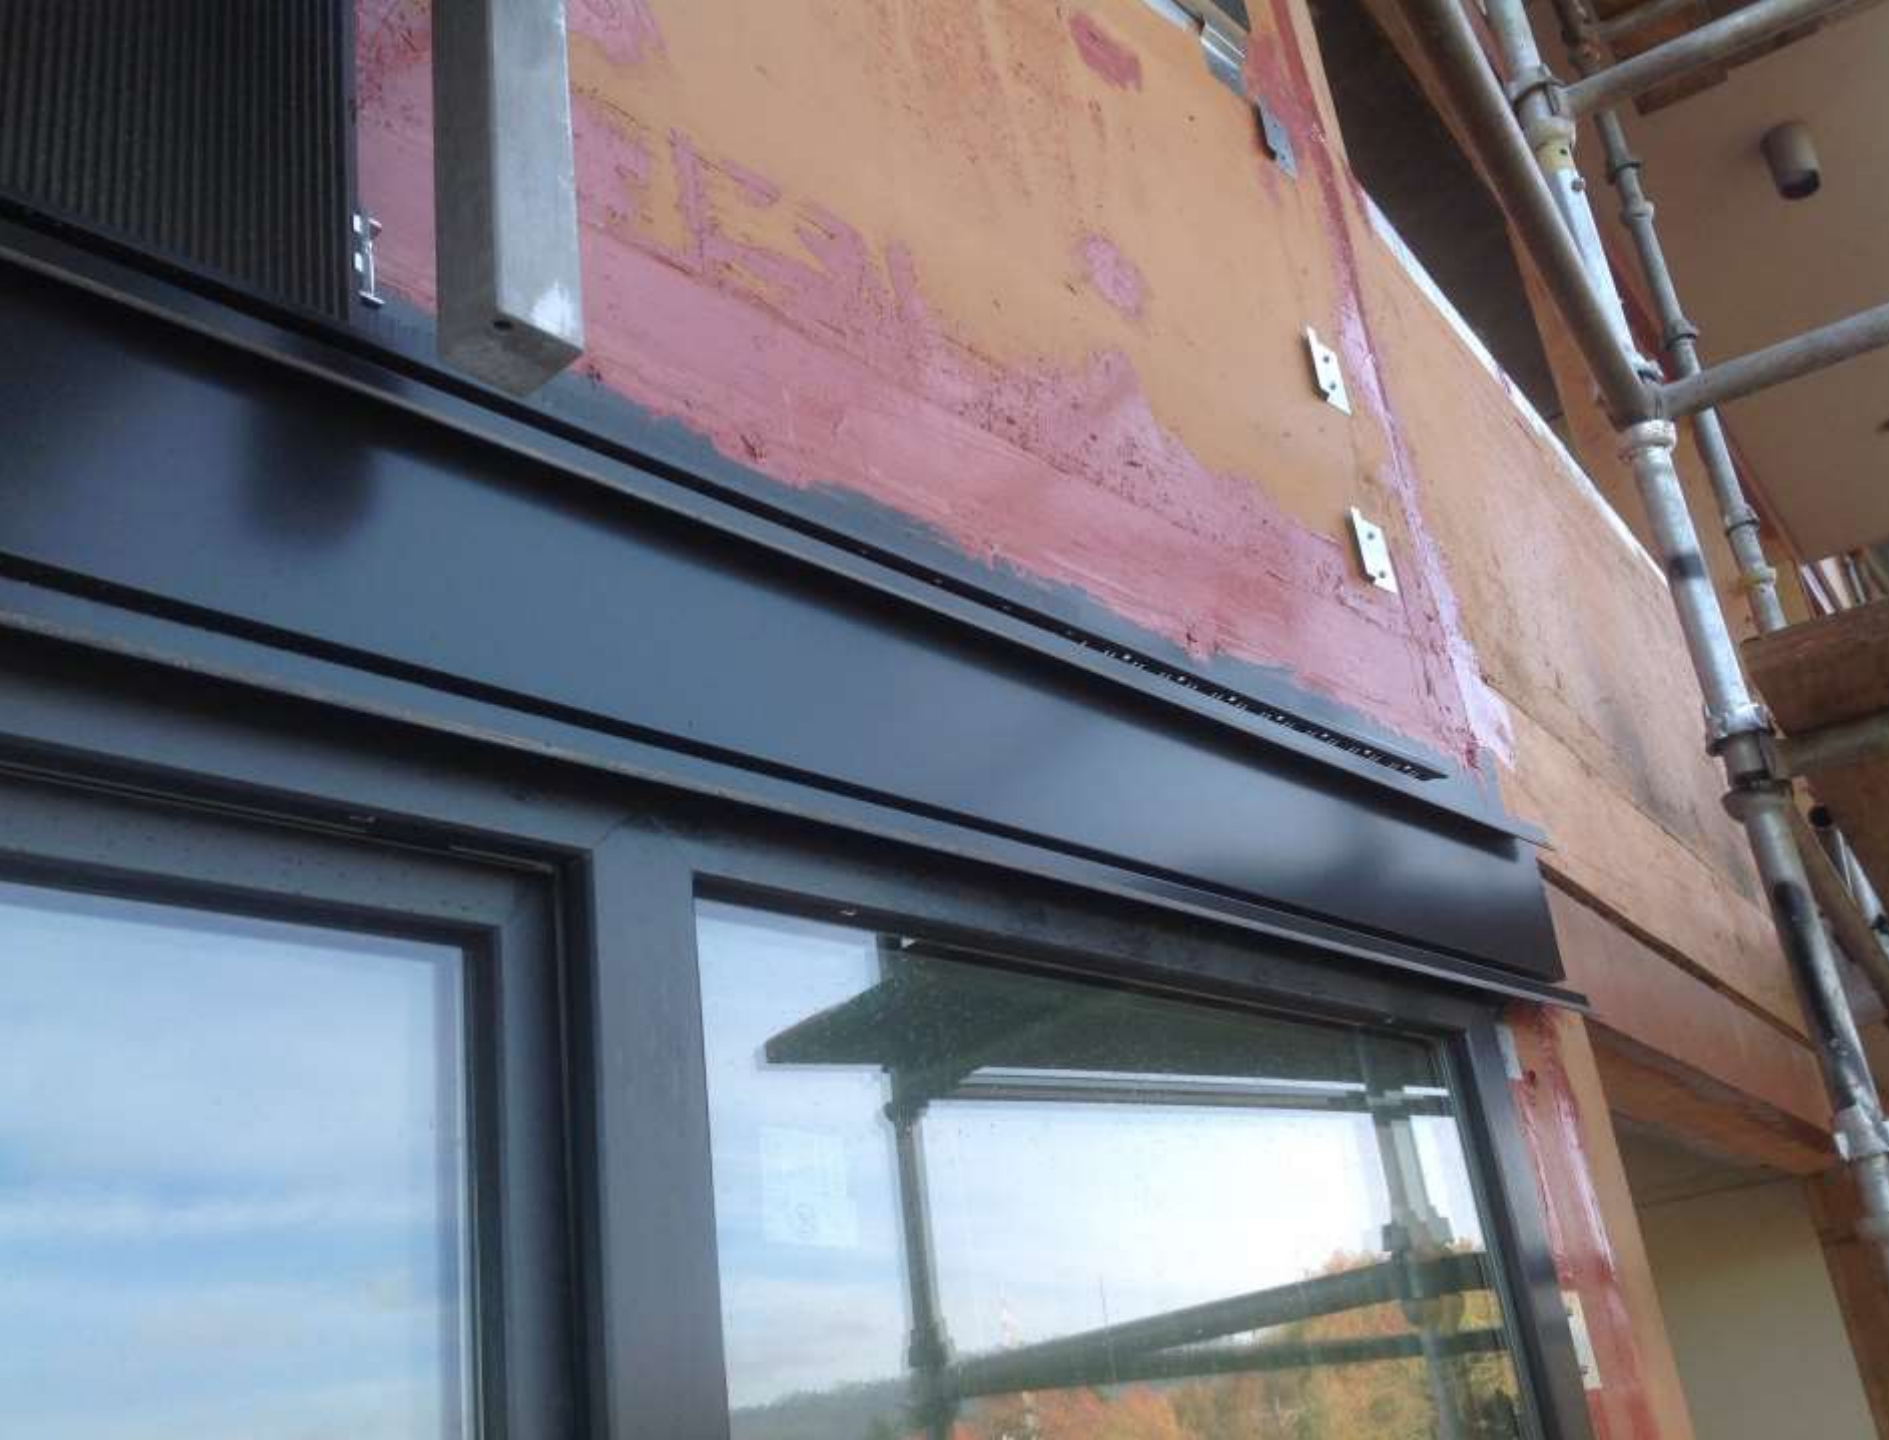
MEP  
Penetrations  
Detailed -  
Ready For  
Rain-screen  
Cladding  
Cover

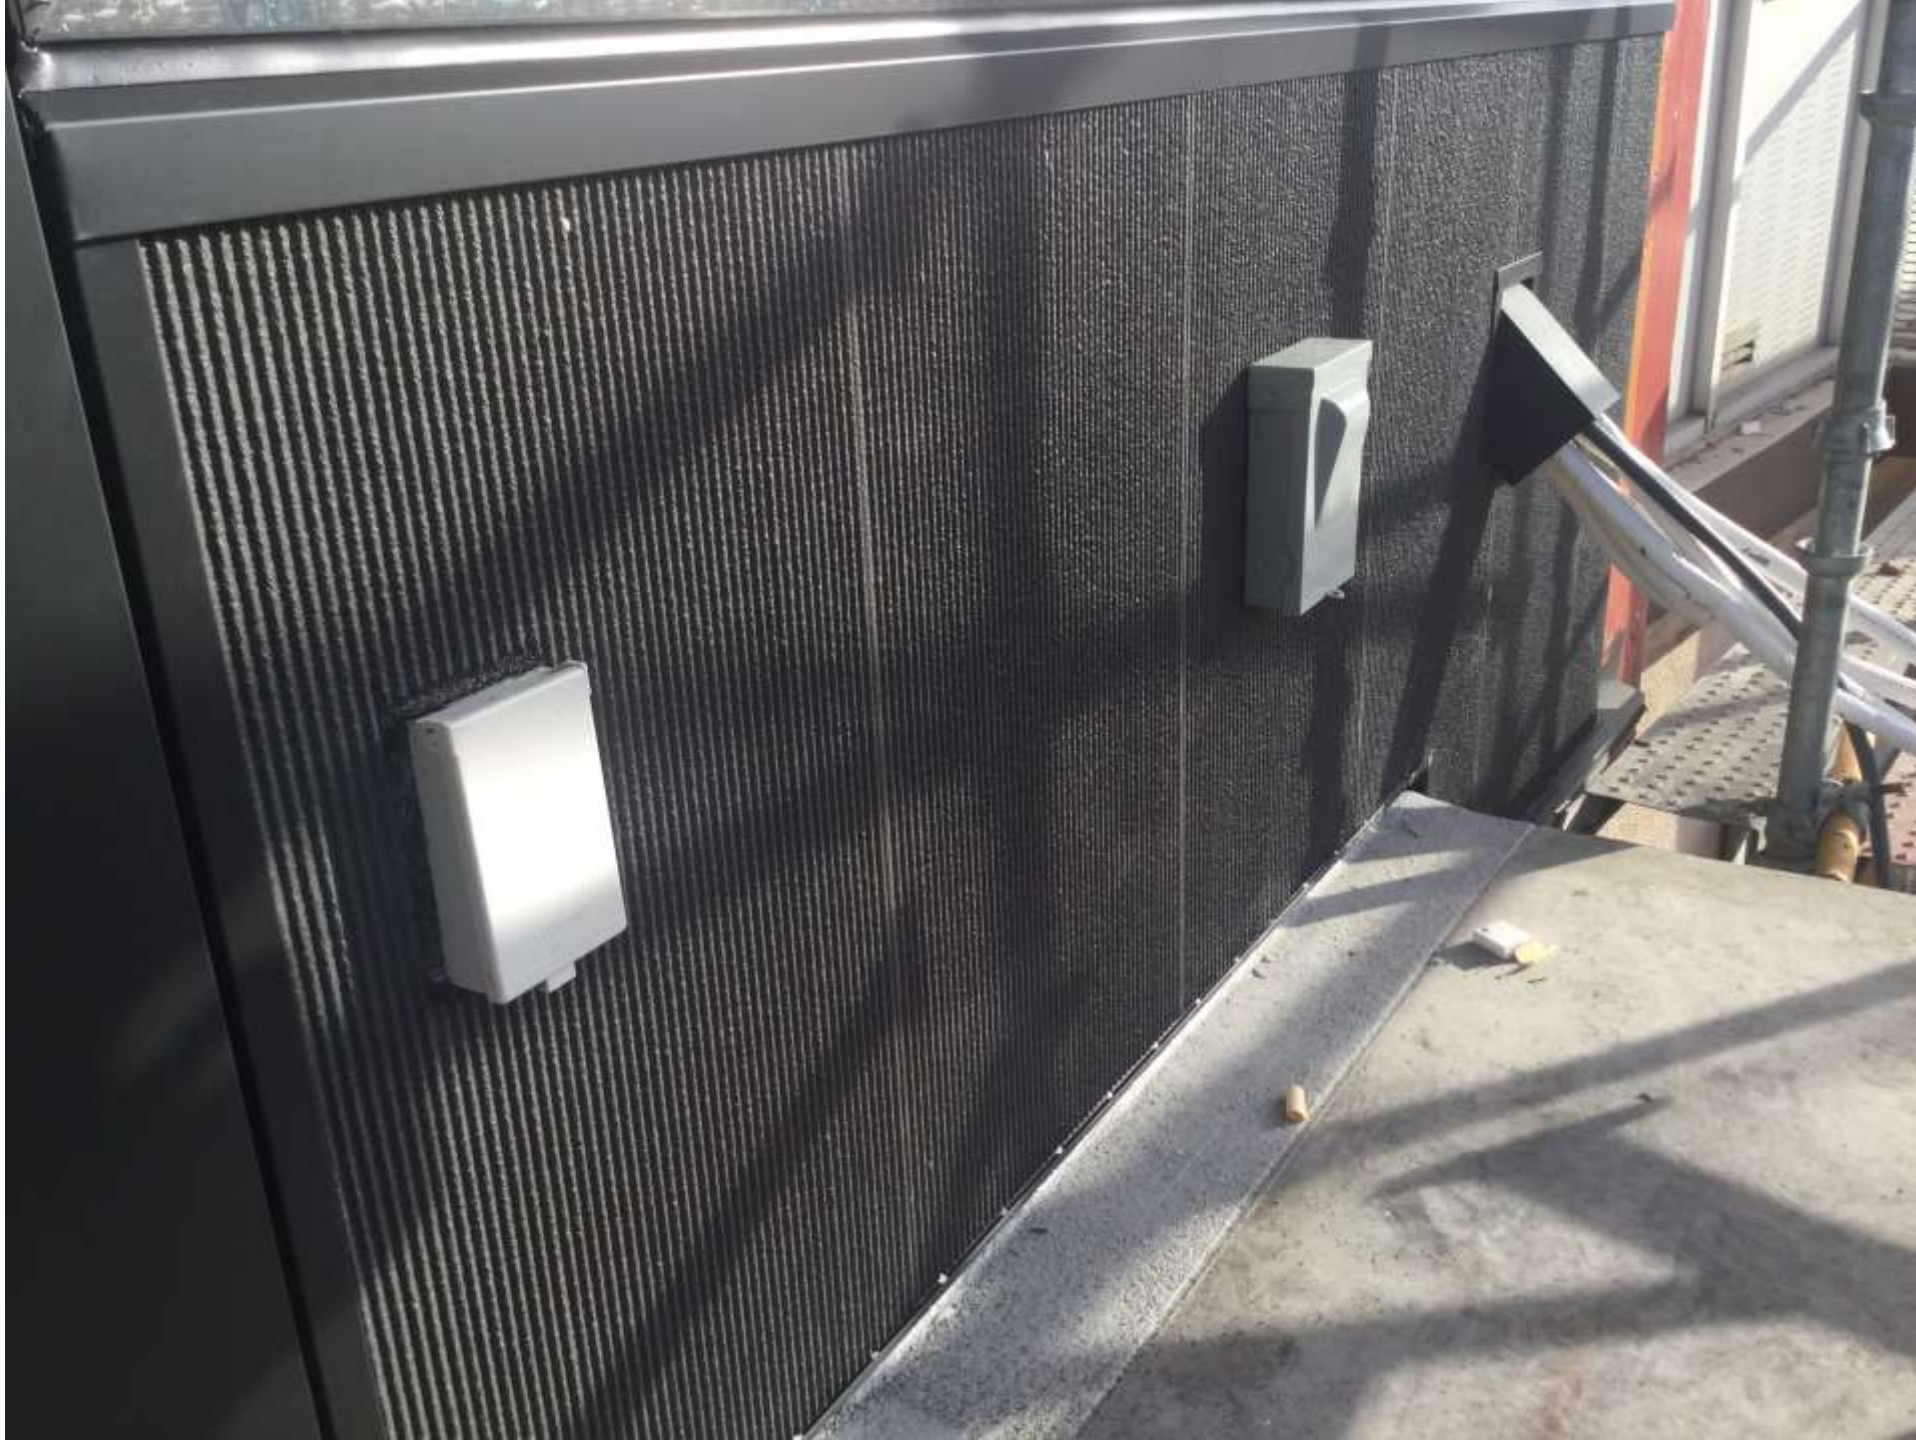
Finished deck  
coating and  
flashing  
interface

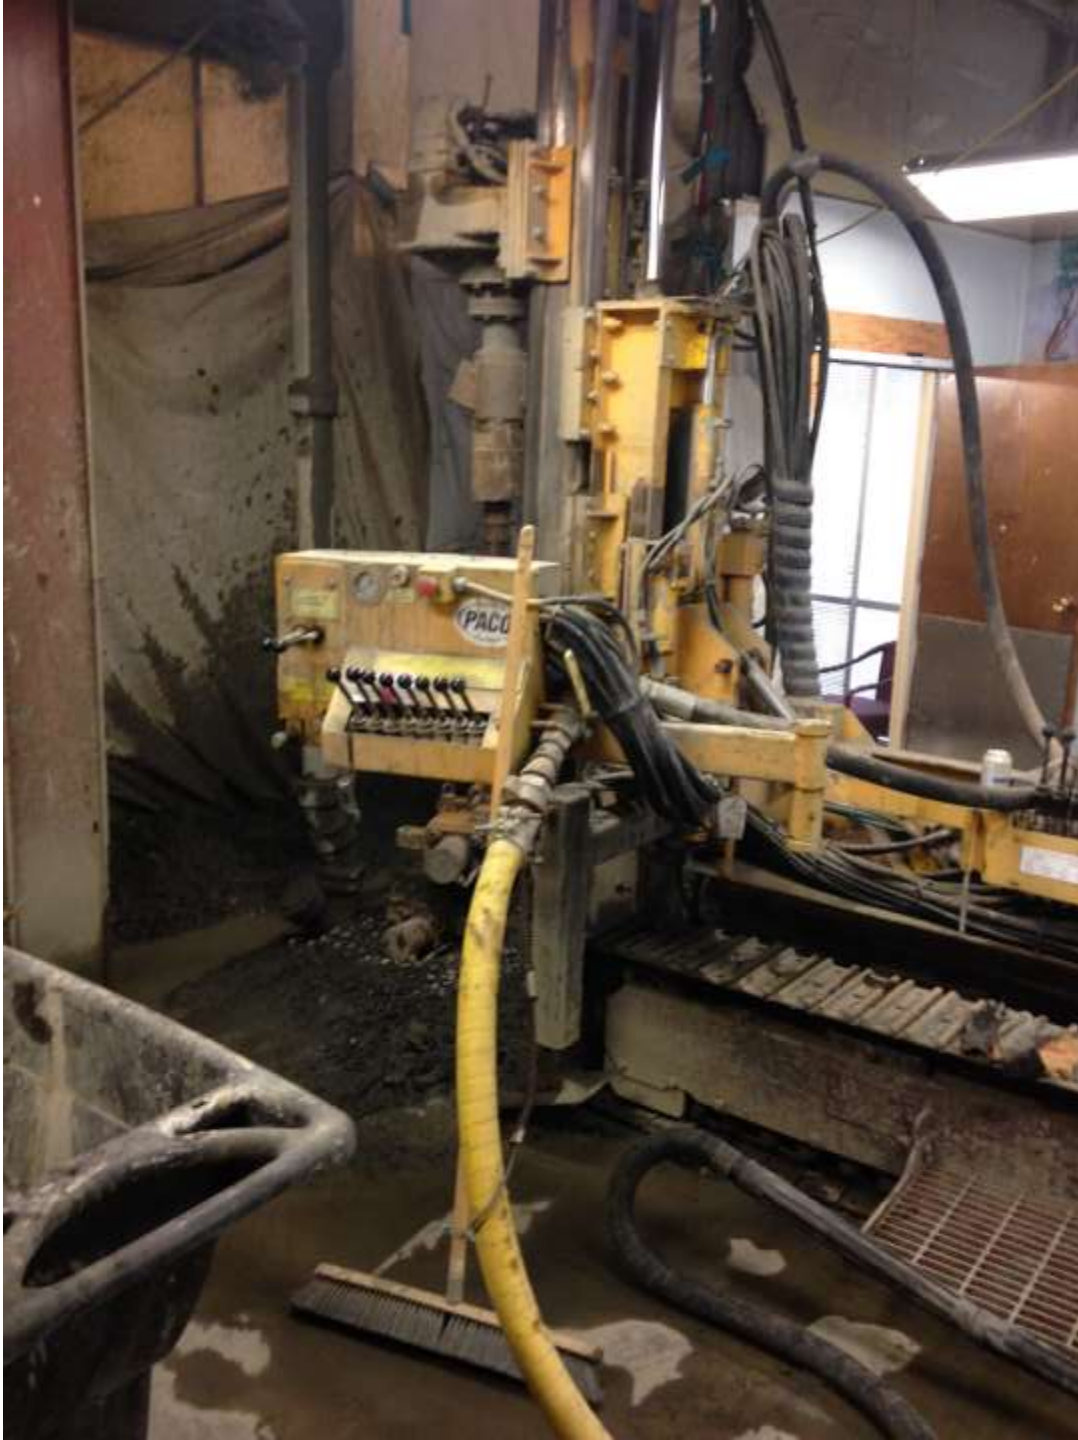
Mobilization of  
Micro-Pile  
Drilling  
Equipment into  
Interior  
Shearwall  
Condition

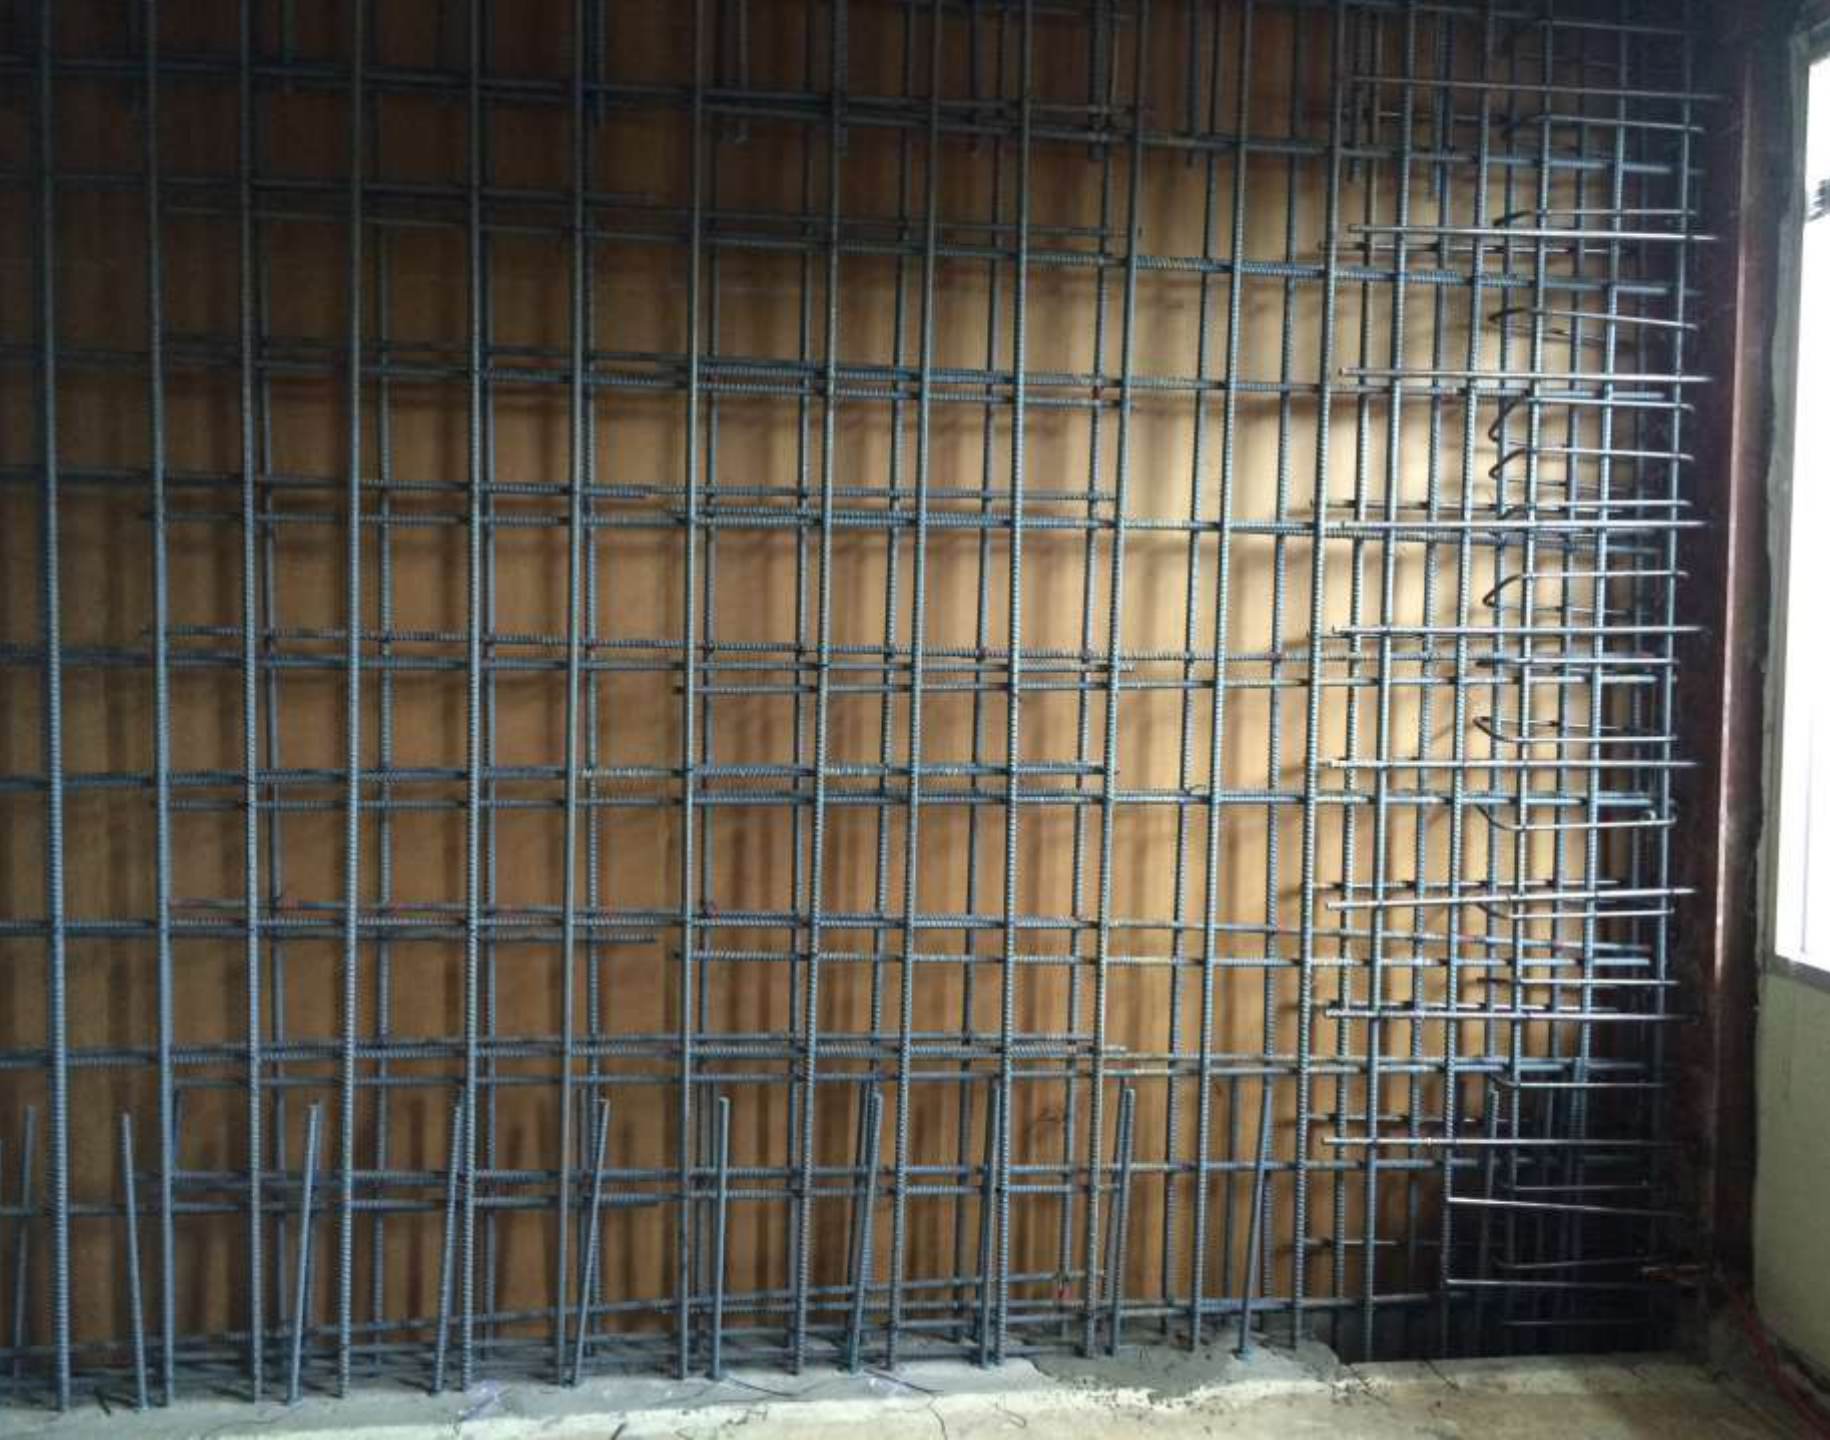
Drilling of Pile No. 2 (of 4) in  
Building Interior –  
Ground Water and Spoils Created  
Substantial Challenges to an  
Occupied Building
